# Access Compliance Report

## Public Rights-of-Way

### (Curb Ramps)

| Intersection ID: 13618 | Main Street: S_CALDWELL_ST | Cross Street: TEMPLETON_AV | Location: E |

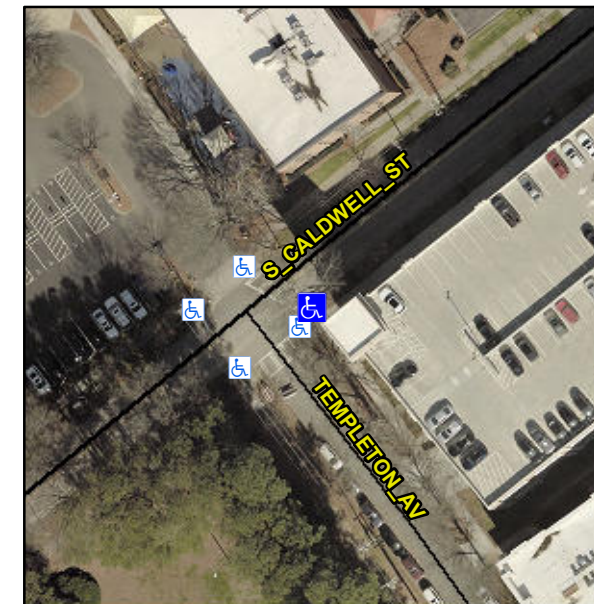
**R305.2**

| Compliance | Description | Data | Compliance | Description | Data |
|---|---|---|---|---|---|
| N/A | Shared Landing? | Yes | No | DWS Offset RT (in) | 12.0 |

**Remove & Replace Detectable Warning System.**

\$ 800.00
