# Access Compliance Report

## Public Rights-of-Way

### (Curb Ramps)

| Intersection ID: 17089 | Main Street: BRIDLEPATH_LN | Cross Street: WALKER_RD | Location: NW |

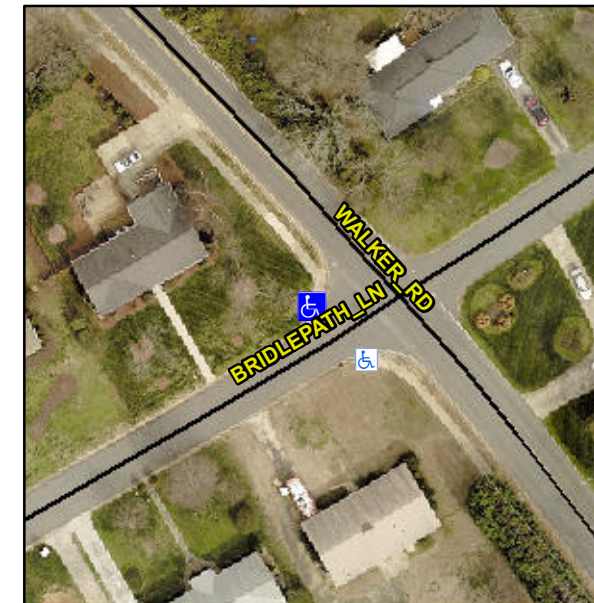
| ADA ID: 441D20267FD2 | Ramp Type: PerpDiag | Initial Pass/Fail: Pass | Overall Compliance: No |
| | | | Severity Score: 11.75 |

**Not Found, R304.5.3, R304.2.1, R304.2.2-Perp, R304.3.2-Para, R305.2, R302.7.2**

| Compliance | Description | Data | Compliance | Description | Data |
|---|---|---|---|---|---|
| N/A | Ramp Length (in) | 27.0 | Yes | Ramp Slope (%) | 6.2 |
| Yes | Ramp Width (in) | 48.0 | No | Ramp XSlope (%) | 2.2 |
| No | Landing Length (in) | 34.0 | Yes | DWS Provided? | Yes |
| No | Landing Width (in) | 39.5 | Yes | DWS Contrast? | Yes |
| No | Landing Slope (%) | 2.2 | Yes | DWS Length (in) | 24.0 |
| No | Landing X Slope (%) | 2.3 | Yes | DWS Full Width? | Yes |
| N/A | Landing Curb? (Y/N) | No | No | DWS Offset (in) | 3.0 |
| No | Gutter Lip Ht (in) | 0.5 | Yes | Gutter X Slope (%) | 2.0 |

**Remove & Replace Curb Ramp With Two New Directional Ramps or Equivalent.**
