Access Compliance Report

Public Rights-of-Way

(Curb Ramps)

Intersection ID: 10034609	Main Street: PLANTATION_CENTER_DR	Cross Street: N/A	Location: SW
ADA ID: 4420F3F78981	Ramp Type: Para	Initial Pass/Fail: Fail	Overall Compliance: No
Codes/Mitigation Info/Possible Solution		Field Measurements/Component Compliance	
Severity Score: 35

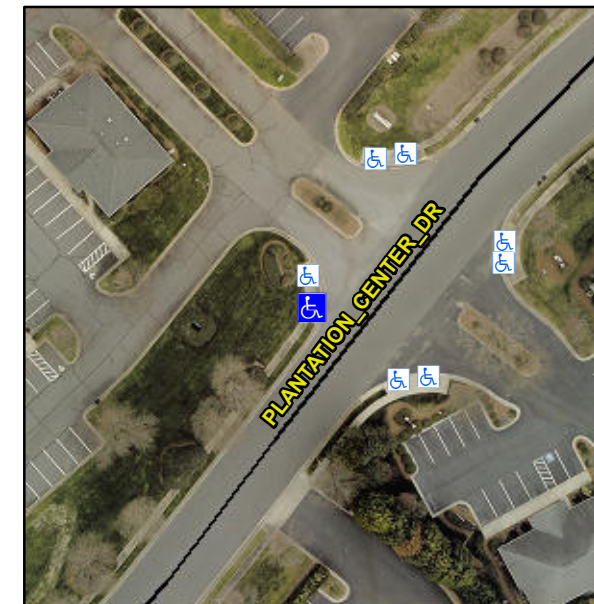
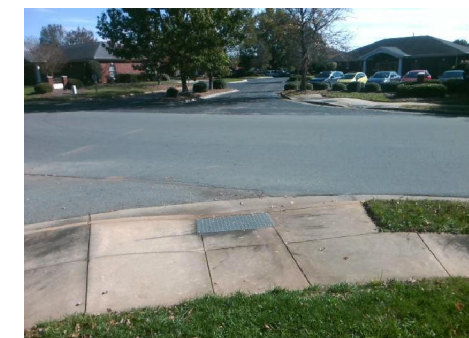
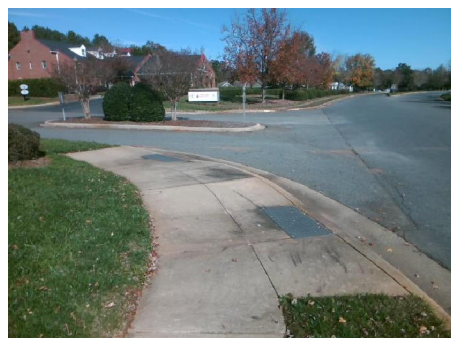
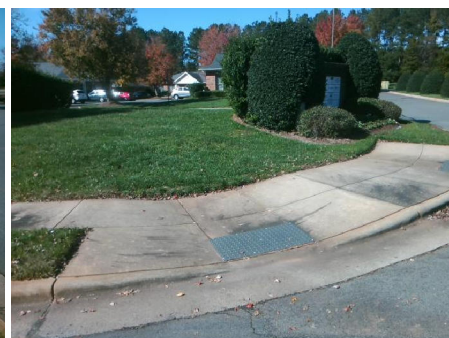
Compliance	Description	Data	Compliance	Description	Data
N/A	Ramp Length LT (in)	60.0	N/A	Ramp Length RT (in)	49.0
No	Ramp Width LT (in)	47.5	Yes	Ramp Width RT (in)	48.0
No	Ramp Slope LT (%)	10.0	No	Ramp Slope RT (%)	14.0
Yes	Ramp XSlope LT (%)	1.7	No	Ramp XSlope RT (%)	2.4
N/A	Landing Length (in)	N/A	N/A	DWS Provided?	N/A
N/A	Landing Width (in)	N/A	N/A	DWS Contrast?	N/A
N/A	Landing Slope (%)	N/A	N/A	DWS Length (in)	N/A
N/A	Landing X Slope (%)	N/A	N/A	DWS Full Width?	N/A
N/A	Landing Curb? (Y/N)	N/A	N/A	DWS Offset (in)	N/A
N/A	Shared Landing?	N/A			
N/A	Gutter Ponding?	N/A	N/A	Gutter Slope (%)	N/A
N/A	Gutter Lip Ht (in)	N/A	N/A	Gutter X Slope (%)	N/A
N/A	Painted X Walk1?	No	N/A	Painted X Walk2?	N/A
	X Walk 1 Direction	To SE		X Walk 2 Direction	N/A
N/A	X Walk 1 Width (in)	N/A	N/A	X Walk 2 Width (in)	N/A
	X Walk 1 Slope (%)	2.7		X Walk 2 Slope (%)	N/A
	X Walk 1 X Slope (%)	0.8		X Walk 2 X Slope (%)	N/A
N/A	Ramp inside XWalk1?	N/A	N/A	Ramp inside XWalk2?	N/A

Road Slope (%)	N/A	N/A	Clear Space?	N/A
	Road X Slope (%)	N/A	N/A	Clear Space to XWalk (in)	N/A
N/A	Any Obstructions?	N/A	N/A	Storm Grate/Utility Hazard?	N/A
	Obstruction Type			Storm Grate/Utility Type	
		N/A			N/A
			Yes	Surface Condition? (G/P)	Good
			N/A	Curb Slope (%)	4.7

Remove & Replace Entire Ramp.

R304.5.1, R304.3.2, R304.5.3
