Access Compliance Report

Public Rights-of-Way

(Curb Ramps)

Intersection ID: 29307	Main Street: OAKDALE_GREEN_DR	Cross Street: WANDERING_CREEK_DR	Location: SE
ADA ID: 4423C3E718AD	Ramp Type: Perp	Initial Pass/Fail: Fail	Overall Compliance: No
Severity Score: 33.75			
Codes/Mitigation Info/Possible Solution		Field Measurements/Component Compliance

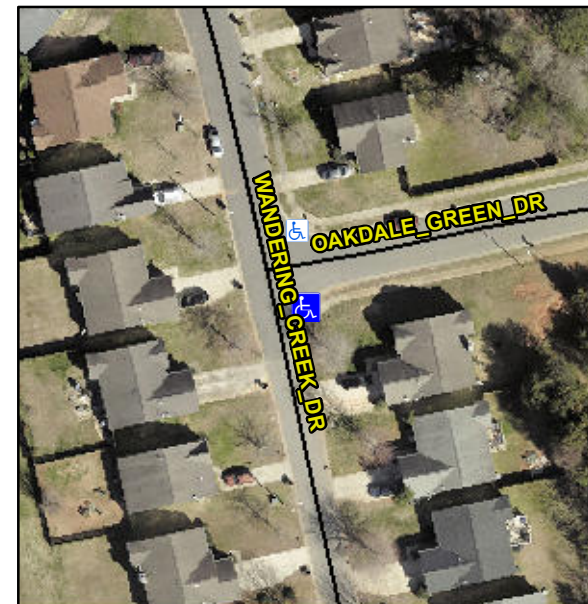
Not Found, R304.5.1, R304.5.3

Compliance	Description	Data	Compliance	Description	Data
N/A	Ramp Length (in)	49.0	Yes	Ramp Slope (%)	5.2
No	Ramp Width (in)	38.0	No	Ramp XSlope (%)	7.0
N/A	Flare Type LT	N/A	N/A	Flare Type RT	N/A
N/A	Flare Slope LT (%)	N/A	N/A	Flare Slope RT (%)	N/A
N/A	Flare Traversable LT?	N/A	N/A	Flare Traversable RT?	N/A
N/A	Landing Length (in)	N/A	N/A	DWS Provided?	N/A
N/A	Landing Width (in)	N/A	N/A	DWS Contrast?	N/A
N/A	Landing Slope (%)	N/A	N/A	DWS Length (in)	N/A
N/A	Landing X Slope (%)	N/A	N/A	DWS Full Width?	N/A
N/A	Landing Curb? (Y/N)	N/A	N/A	DWS Offset (in)	N/A
N/A	Shared Landing?	N/A			
N/A	Gutter Ponding?	N/A	N/A	Gutter Slope (%)	N/A
N/A	Gutter Lip Ht (in)	N/A	N/A	Gutter X Slope (%)	N/A
N/A	Painted X Walk1?	No	N/A	Painted X Walk2?	N/A
	X Walk 1 Direction	To N		X Walk 2 Direction	N/A
N/A	X Walk 1 Width (in)	N/A	N/A	X Walk 2 Width (in)	N/A
	X Walk 1 Slope (%)	0.2		X Walk 2 Slope (%)	N/A
	X Walk 1 X Slope (%)	5.3		X Walk 2 X Slope (%)	N/A

N/A	Ramp inside XWalk1?	N/A	N/A	Ramp inside XWalk2?	N/A
	Road Slope (%)	N/A	N/A	Clear Space?	N/A
	Road X Slope (%)	N/A	N/A	Clear Space to XWalk (in)	N/A
N/A	Any Obstructions?	N/A	N/A	Storm Grate/Utility Hazard?	N/A
	Obstruction Type			Storm Grate/Utility Type	
		N/A			N/A
			Yes	Surface Condition? (G/P)	Good

Possible Solutions:

Remove & Replace Entire Ramp.

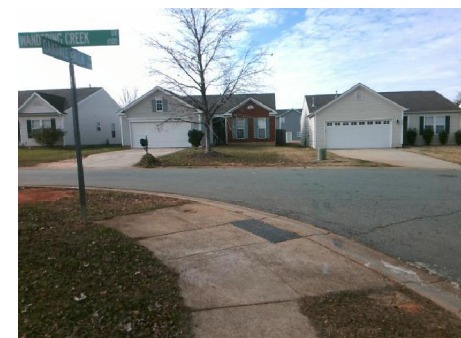
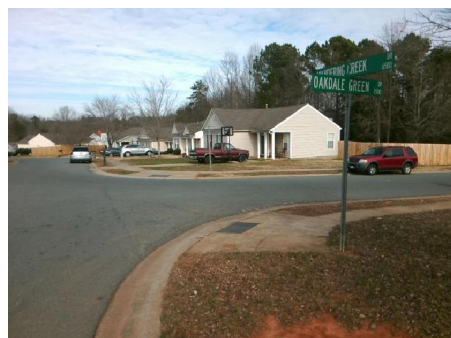
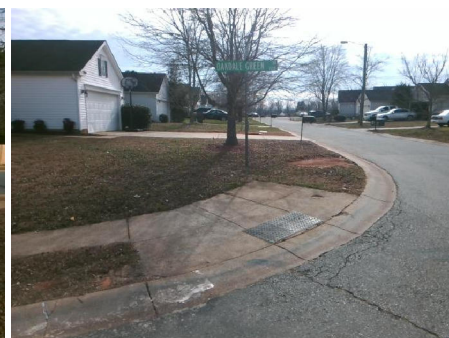
Street 1 Name **OAKDALE GREEN DR**
 Stop Condition-Street 2 **StopSign**
 Street 2 Name **N/A**
 Stop Condition-Street 1 **N/A**
