Access Compliance Report

Public Rights-of-Way

(Curb Ramps)

Intersection ID: 11302	Main Street: MEADOWCLIFF_DR	Cross Street: STEPPING_STONE_DR	Location: E
ADA ID: 44324E6909EB	Ramp Type: BlendTrans1	Initial Pass/Fail: Fail	Overall Compliance: No
Severity Score: 8.75			
Codes/Mitigation Info/Possible Solution		Field Measurements/Component Compliance

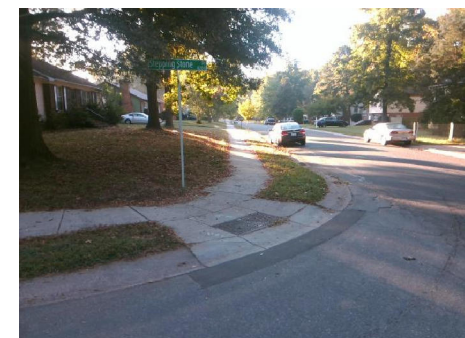
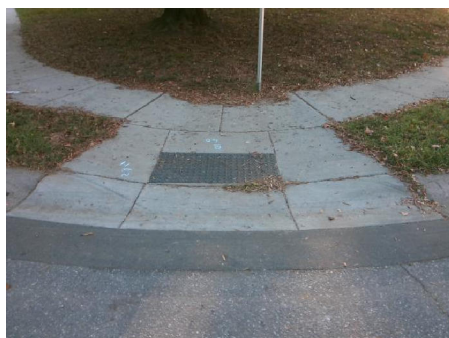
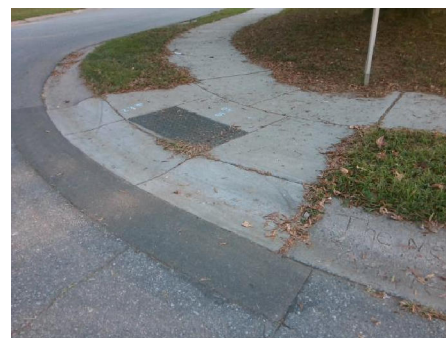
Compliance	Description	Data	Compliance	Description	Data
N/A	Ramp Length (in)	48.0	Yes	BlendTrans Slope (%)	1.0
No	Ramp Width (in)	47.0	Yes	BlendTrans XSlope (%)	0.4
N/A	Flare Type LT	N/A	N/A	Flare Type RT	N/A
N/A	Flare Slope LT (%)	N/A	N/A	Flare Slope RT (%)	N/A
N/A	Flare Traversable LT?	N/A	N/A	Flare Traversable RT?	N/A
N/A	Landing Length (in)	N/A	N/A	DWS Provided?	N/A
N/A	Landing Width (in)	N/A	N/A	DWS Contrast?	N/A
N/A	Landing Slope (%)	N/A	N/A	DWS Length (in)	N/A
N/A	Landing X Slope (%)	N/A	N/A	DWS Full Width?	N/A
N/A	Landing Curb? (Y/N)	N/A	N/A	DWS Offset (in)	N/A
N/A	Shared Landing?	N/A			
N/A	Gutter Ponding?	N/A	N/A	Gutter Slope (%)	N/A
N/A	Gutter Lip Ht (in)	N/A	N/A	Gutter X Slope (%)	N/A
N/A	Painted X Walk1?	No	N/A	Painted X Walk2?	N/A
	X Walk 1 Direction	To NW		X Walk 2 Direction	N/A
	X Walk 1 Width (in)	N/A		X Walk 2 Width (in)	N/A
	X Walk 1 Slope (%)	0.2		X Walk 2 Slope (%)	N/A
	X Walk 1 X Slope (%)	1.1		X Walk 2 X Slope (%)	N/A

N/A	Ramp inside XWalk1?	N/A	N/A	Ramp inside XWalk2?	N/A
	Road Slope (%)	1.1		Clear Space?	N/A
	Road X Slope (%)	0.2	N/A	Clear Space to XWalk (in)	N/A
N/A	Any Obstructions?	N/A	N/A	Storm Grate/Utility Hazard?	N/A
	Obstruction Type			Storm Grate/Utility Type	
		N/A			N/A
			Yes	Surface Condition? (G/P)	Good
			No	Curb Slope (%)	13.0

Remove & Replace Curb Ramp With Two New Directional Ramps or Equivalent.
