Access Compliance Report

Public Rights-of-Way

(Curb Ramps)

Intersection ID: 50603	Main Street: RHODORA_RD	Cross Street: EMPRESS_CT	Location:	N
ADA ID: 443515FA5B48	Ramp Type: Perp	Initial Pass/Fail: Fail	Overall Compliance: No	Severity Score: 35
Codes/Mitigation Info/Possible Solution		Field Measurements/Component Compliance

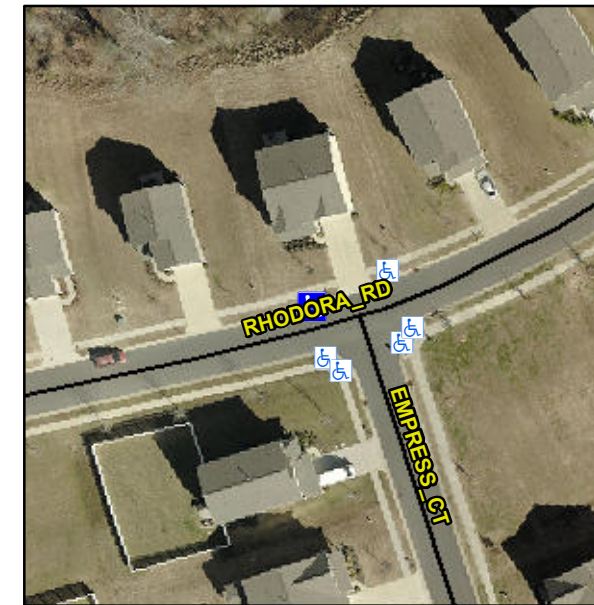
Compliance	Description	Data	Compliance	Description	Data
N/A	Ramp Length (in)	49.0	No	Ramp Slope (%)	14.5
No	Ramp Width (in)	47.5	Yes	Ramp XSlope (%)	2.3
N/A	Flare Type LT	N/A	N/A	Flare Type RT	N/A
N/A	Flare Slope LT (%)	N/A	N/A	Flare Slope RT (%)	N/A
N/A	Flare Traversable LT?	N/A	N/A	Flare Traversable RT?	N/A
N/A	Landing Length (in)	N/A	N/A	DWS Provided?	N/A
N/A	Landing Width (in)	N/A	N/A	DWS Contrast?	N/A
N/A	Landing Slope (%)	N/A	N/A	DWS Length (in)	N/A
N/A	Landing X Slope (%)	N/A	N/A	DWS Full Width?	N/A
N/A	Landing Curb? (Y/N)	N/A	N/A	DWS Offset (in)	N/A
N/A	Shared Landing?	N/A			
N/A	Gutter Ponding?	N/A	N/A	Gutter Slope (%)	N/A
N/A	Gutter Lip Ht (in)	N/A	N/A	Gutter X Slope (%)	N/A
N/A	Painted X Walk1?	No	N/A	Painted X Walk2?	N/A
	X Walk 1 Direction	To S		X Walk 2 Direction	N/A
N/A	X Walk 1 Width (in)	N/A	N/A	X Walk 2 Width (in)	N/A
	X Walk 1 Slope (%)	3.8		X Walk 2 Slope (%)	N/A
	X Walk 1 X Slope (%)	3.1		X Walk 2 X Slope (%)	N/A

N/A	Ramp inside XWalk1?	N/A	N/A	Ramp inside XWalk2?	N/A
	Road Slope (%)	N/A	N/A	Clear Space?	N/A
	Road X Slope (%)	N/A	N/A	Clear Space to XWalk (in)	N/A
N/A	Any Obstructions?	N/A	N/A	Storm Grate/Utility Hazard?	N/A
	Obstruction Type			Storm Grate/Utility Type	
		N/A			N/A
			Yes	Surface Condition? (G/P)	Good

Possible Solutions:

Remove & Replace Entire Ramp.

R304.5.1, R304.2.2
