Access Compliance Report

Public Rights-of-Way

(Curb Ramps)

Intersection ID: 10274	Main Street: N_POPLAR_ST	Cross Street: W_24TH_ST	Location: SW
ADA ID: 443847A84277	Ramp Type: Perp	Initial Pass/Fail: Fail	Overall Compliance: No
		Severity Score: 22.5

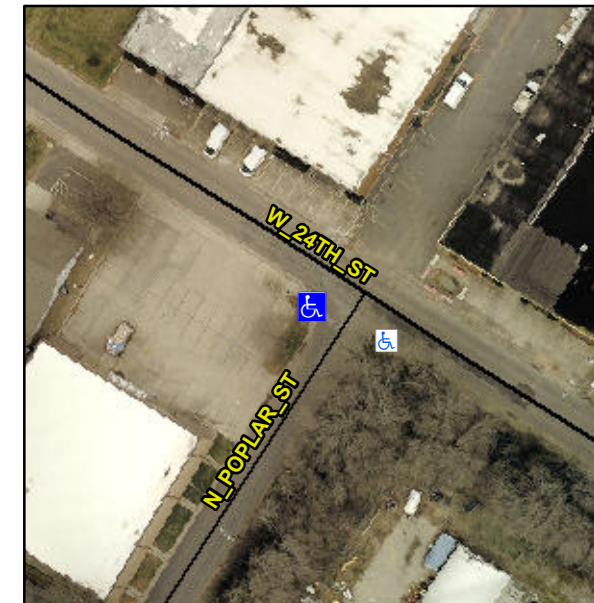
Not Found, R304.5.1, R304.2.2, R304.5.3

Compliance	Description	Data	Compliance	Description	Data
N/A	Ramp Length (in)	60.0	No	Ramp Slope (%)	9.7
No	Ramp Width (in)	47.0	No	Ramp XSlope (%)	4.4
N/A	Flare Type LT	N/A	N/A	Flare Type RT	N/A
N/A	Flare Slope LT (%)	N/A	N/A	Flare Slope RT (%)	N/A
N/A	Flare Traversable LT?	N/A	N/A	Flare Traversable RT?	N/A
N/A	Landing Length (in)	N/A	N/A	DWS Provided?	N/A
N/A	Landing Width (in)	N/A	N/A	DWS Contrast?	N/A
N/A	Landing Slope (%)	N/A	N/A	DWS Length (in)	N/A
N/A	Landing X Slope (%)	N/A	N/A	DWS Full Width?	N/A
N/A	Landing Curb? (Y/N)	N/A	N/A	DWS Offset (in)	N/A
N/A	Shared Landing?	N/A			
N/A	Gutter Ponding?	N/A	N/A	Gutter Slope (%)	N/A
N/A	Gutter Lip Ht (in)	N/A	N/A	Gutter X Slope (%)	N/A
N/A	Painted X Walk1?	No	N/A	Painted X Walk2?	N/A
	X Walk 1 Direction	To SE		X Walk 2 Direction	N/A
N/A	X Walk 1 Width (in)	N/A	N/A	X Walk 2 Width (in)	N/A
	X Walk 1 Slope (%)	0.6		X Walk 2 Slope (%)	N/A
	X Walk 1 X Slope (%)	2.3		X Walk 2 X Slope (%)	N/A

N/A	Ramp inside XWalk1?	N/A	N/A	Ramp inside XWalk2?	N/A
	Road Slope (%)	N/A	N/A	Clear Space?	N/A
	Road X Slope (%)	N/A	N/A	Clear Space to XWalk (in)	N/A
N/A	Any Obstructions?	N/A	N/A	Storm Grate/Utility Hazard?	N/A
	Obstruction Type			Storm Grate/Utility Type	
		N/A			N/A
			Yes	Surface Condition? (G/P)	Good

Possible Solutions:

Remove & Replace Entire Ramp.
