# Access Compliance Report

## Public Rights-of-Way

### (Curb Ramps)

| Intersection ID: 46818 | Main Street: HOLM_OAK_PL | Cross Street: AZALEA_HILLS_DR | Location: SE |

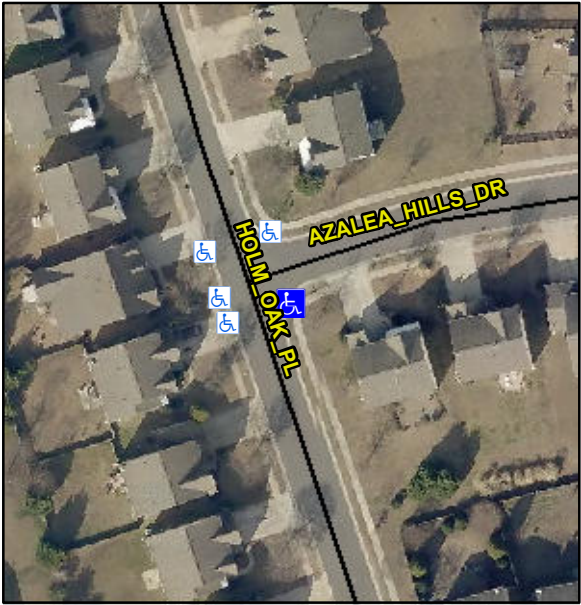
| ADA ID: 444189A4207D | Ramp Type: PerpDiag | Initial Pass/Fail: Fail | Overall Compliance: No |

| Codes/Mitigation Info/Possible Solution | | | Field Measurements/Component Compliance | | |
|---|---|--|---|---|---|
| | <b>Remove &amp; Replace Curb Ramp With Two New Directional Ramps or Equivalent.</b> | | <b>No</b> | Ramp Length (in) | <b>46.5</b> |
| <p>Surveyor Notes:</p> <p><b>N/A</b></p> <p>PROW/ADA:</p> <p><b>R304.2.2, R304.5.3</b></p> | | | <b>N/A</b> | Flare Type RT | <b>N/A</b> |

| Codes/Mitigation Info/Possible Solution | | | Field Measurements/Component Compliance | | |
|---|---|--|---|---|---|
| <p>Total Cost:</p> <p><b>\$ 3200.00</b></p> | | | <b>No</b> | Painted X Walk2? | <b>No</b> |
