Access Compliance Report

Public Rights-of-Way

(Curb Ramps)

Intersection ID: 7834	Main Street: BILMARK_AV	Cross Street: SNOW_WHITE_LN	Location: SW
ADA ID: 4443EA3ACFCD	Ramp Type: Perp	Initial Pass/Fail: Fail	Overall Compliance: No
			Severity Score: 35

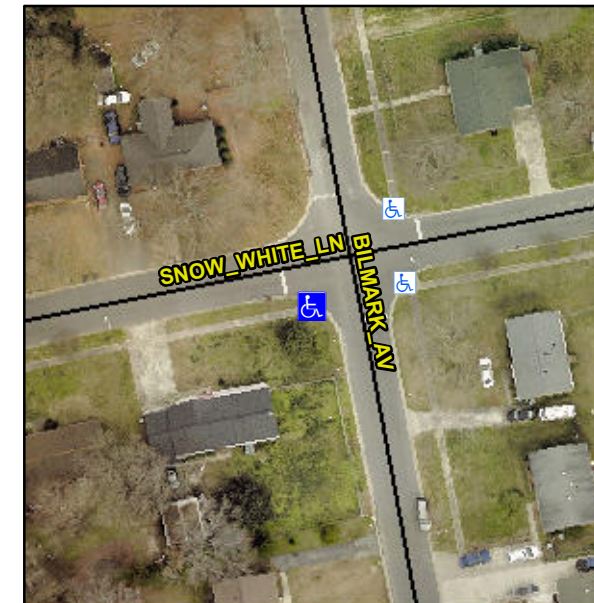
Not Found, R304.5.1, R304.2.2, R304.5.3

Compliance	Description	Data	Compliance	Description	Data
N/A	Ramp Length (in)	30.0	No	Ramp Slope (%)	12.5
No	Ramp Width (in)	46.0	No	Ramp XSlope (%)	3.8
N/A	Flare Type LT	N/A	N/A	Flare Type RT	N/A
N/A	Flare Slope LT (%)	N/A	N/A	Flare Slope RT (%)	N/A
N/A	Flare Traversable LT?	N/A	N/A	Flare Traversable RT?	N/A
N/A	Landing Length (in)	N/A	N/A	DWS Provided?	N/A
N/A	Landing Width (in)	N/A	N/A	DWS Contrast?	N/A
N/A	Landing Slope (%)	N/A	N/A	DWS Length (in)	N/A
N/A	Landing X Slope (%)	N/A	N/A	DWS Full Width?	N/A
N/A	Landing Curb? (Y/N)	N/A	N/A	DWS Offset (in)	N/A
N/A	Shared Landing?	N/A			
N/A	Gutter Ponding?	N/A	N/A	Gutter Slope (%)	N/A
N/A	Gutter Lip Ht (in)	0.5	N/A	Gutter X Slope (%)	N/A
N/A	Painted X Walk1?	No	N/A	Painted X Walk2?	N/A
	X Walk 1 Direction	To E		X Walk 2 Direction	N/A
N/A	X Walk 1 Width (in)	N/A	N/A	X Walk 2 Width (in)	N/A
	X Walk 1 Slope (%)	1.2		X Walk 2 Slope (%)	N/A
	X Walk 1 X Slope (%)	3.6		X Walk 2 X Slope (%)	N/A

N/A	Ramp inside XWalk1?	N/A	N/A	Ramp inside XWalk2?	N/A
	Road Slope (%)	N/A	N/A	Clear Space?	N/A
	Road X Slope (%)	N/A	N/A	Clear Space to XWalk (in)	N/A
N/A	Any Obstructions?	N/A	N/A	Storm Grate/Utility Hazard?	N/A
	Obstruction Type			Storm Grate/Utility Type	
		N/A			N/A
			Yes	Surface Condition? (G/P)	Good

Remove & Replace Entire Ramp.
