# Access Compliance Report

## Public Rights-of-Way

| Intersection ID: 14469 | Main Street: E_MOREHEAD_ST | Cross Street: KENILWORTH_AV | Location: S |
| ADA ID: 4447AE894CB0 | Ramp Type: Perp | Initial Pass/Fail: Fail | Overall Compliance: No |

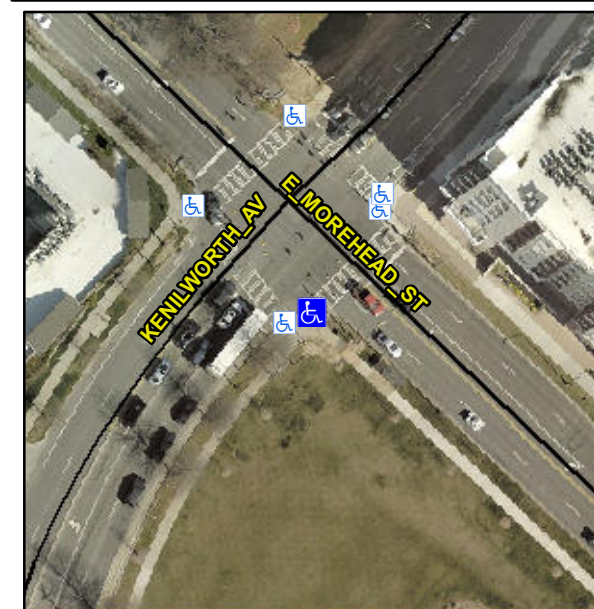
**Not Found, R304.5.1, R304.5.3**

| Compliance | Description | Data | Compliance | Description | Data |
|---|---|---|---|---|---|
| N/A | Ramp Length (in) | 84.0 | Yes | Ramp Slope (%) | 7.9 |
| No | Ramp Width (in) | 47.0 | No | Ramp XSlope (%) | 5.8 |

**Remove & Replace Entire Ramp.**

Total Cost: \$ 1850.00
