# Access Compliance Report

## Public Rights-of-Way

Intersection ID: 10028571	Main Street: HOLLYBUSH_LN	Cross Street: N/A	Location: NE
ADA ID: 44557FB4695F	Ramp Type: Perp	Initial Pass/Fail: Fail	Overall Compliance: No
Severity Score: 46.25			
Codes/Mitigation Info/Possible Solution		Field Measurements/Component Compliance

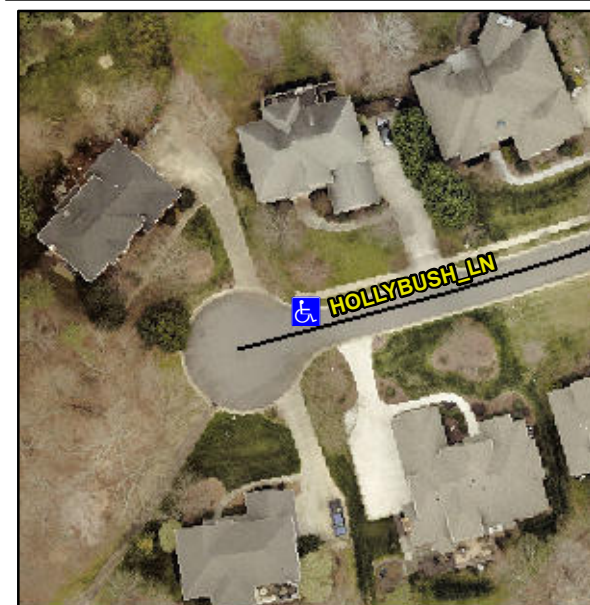
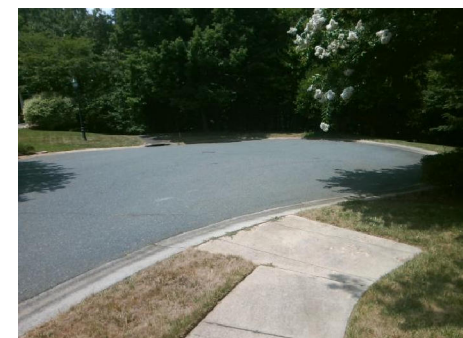
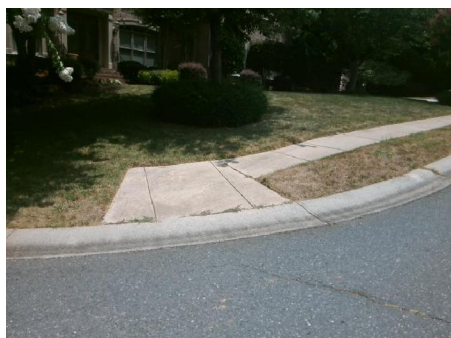
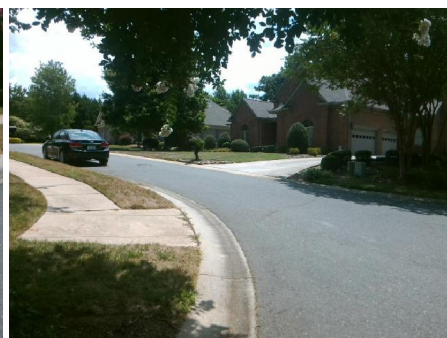
**Not Found, R304.5.1, R304.2.2, R304.5.3**

Compliance	Description	Data	Compliance	Description	Data
N/A	Ramp Length (in)	96.0	No	Ramp Slope (%)	8.9
No	Ramp Width (in)	47.0	No	Ramp XSlope (%)	11.9
N/A	Flare Type LT	N/A	N/A	Flare Type RT	N/A
N/A	Flare Slope LT (%)	N/A	N/A	Flare Slope RT (%)	N/A
N/A	Flare Traversable LT?	N/A	N/A	Flare Traversable RT?	N/A
N/A	Landing Length (in)	N/A	N/A	DWS Provided?	N/A
N/A	Landing Width (in)	N/A	N/A	DWS Contrast?	N/A
N/A	Landing Slope (%)	N/A	N/A	DWS Length (in)	N/A
N/A	Landing X Slope (%)	N/A	N/A	DWS Full Width?	N/A
N/A	Landing Curb? (Y/N)	N/A	N/A	DWS Offset (in)	N/A
N/A	Shared Landing?	N/A			
N/A	Gutter Ponding?	N/A	N/A	Gutter Slope (%)	N/A
N/A	Gutter Lip Ht (in)	N/A	N/A	Gutter X Slope (%)	N/A
N/A	Painted X Walk1?	No	N/A	Painted X Walk2?	N/A
	X Walk 1 Direction	To S		X Walk 2 Direction	N/A
N/A	X Walk 1 Width (in)	N/A	N/A	X Walk 2 Width (in)	N/A
	X Walk 1 Slope (%)	1.3		X Walk 2 Slope (%)	N/A
	X Walk 1 X Slope (%)	8.9		X Walk 2 X Slope (%)	N/A

N/A	Ramp inside XWalk1?	N/A	N/A	Ramp inside XWalk2?	N/A
	Road Slope (%)	N/A	N/A	Clear Space?	N/A
	Road X Slope (%)	N/A	N/A	Clear Space to XWalk (in)	N/A
N/A	Any Obstructions?	N/A	N/A	Storm Grate/Utility Hazard?	N/A
	Obstruction Type			Storm Grate/Utility Type	
		N/A			N/A
			Yes	Surface Condition? (G/P)	Good

**Remove & Replace Entire Ramp.**

Total Cost: \$ 1850.00
