Access Compliance Report

Public Rights-of-Way

(Curb Ramps)

Intersection ID: 17677	Main Street: BROADMOOR_DR	Cross Street: SCALEYBARK_RD	Location:	N
ADA ID: 4459E02597BD	Ramp Type: Directional1	Initial Pass/Fail: Pass	Overall Compliance: No	Severity Score: 0

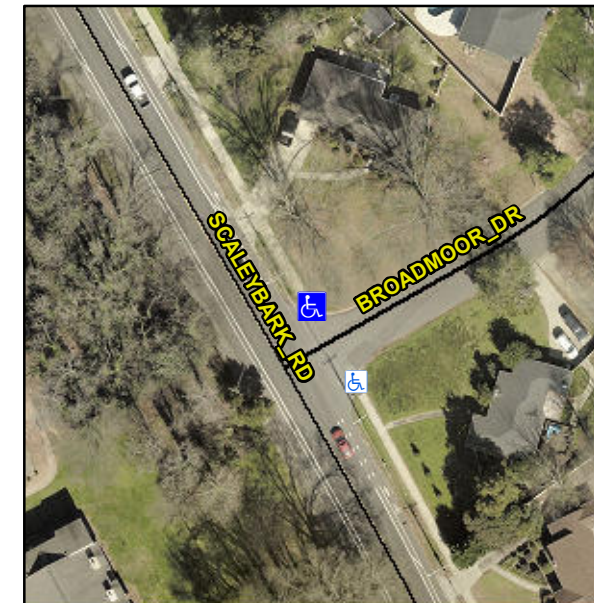
**Not Found, R304.2.2-Perp, R304.3.2-
Para, R304.5.2, R305.2, R304.5.3**

Compliance	Description	Data	Compliance	Description	Data
N/A	Ramp Length (in)	158.0	No	Grade Break?	No
Yes	Ramp Width (in)	71.0	N/A	Grade Break Slope (%)	5.0
Yes	Ramp Slope (%)	6.6	N/A	Grade Break XSlope (%)	0.0
Yes	Ramp XSlope (%)	1.7			
N/A	Flare Type LT	N/A	N/A	Flare Type RT	N/A
N/A	Flare Slope LT (%)	N/A	N/A	Flare Slope RT (%)	N/A
N/A	Flare Traversable LT?	N/A	N/A	Flare Traversable RT?	N/A
Yes	Landing Length (in)	48.0	Yes	DWS Provided?	Yes
Yes	Landing Width (in)	72.0	Yes	DWS Contrast?	Yes
No	Landing Slope (%)	4.8	Yes	DWS Length (in)	24.0
Yes	Landing X Slope (%)	1.2	Yes	DWS Full Width?	Yes
N/A	Landing Curb? (Y/N)	N/A	No	DWS Offset LT (in)	3.0
N/A	Shared Landing?	No	No	DWS Offset RT (in)	75.0
Yes	Gutter Ponding?	No	Yes	Gutter Slope (%)	2.2
Yes	Gutter Lip Ht (in)	0.0	No	Gutter X Slope (%)	3.7
N/A	Painted X Walk1?	No		Road Slope (%)	1.6
	X Walk 1 Direction	To SE		Road X Slope (%)	2.8
	X Walk 1 Width (in)	N/A		Clear Space?	Yes

X Walk 1 Slope (%)	1.6	N/A	Clear Space to XWalk (in)	N/A
	X Walk 1 X Slope (%)	2.8	Yes	Storm Grate/Utility Hazard?	No
N/A	Ramp inside XWalk1?	N/A		Storm Grate/Utility Type	
Yes	Any Obstructions?	No			N/A
	Obstruction Type		Yes	Surface Condition? (G/P)	Good
			N/A	Curb Slope (%)	14.1

**Remove & Replace Entire Ramp.
Remove & Replace Gutter.**
