Access Compliance Report

Public Rights-of-Way

(Curb Ramps)

Intersection ID: 14508	Main Street: CLANCY_PL	Cross Street: DWIGHTWARE_BV	Location: NE
ADA ID: 446E67E60EBB	Ramp Type: PerpDiag	Initial Pass/Fail: Fail	Overall Compliance: No
Severity Score: 12.5			
Codes/Mitigation Info/Possible Solution		Field Measurements/Component Compliance

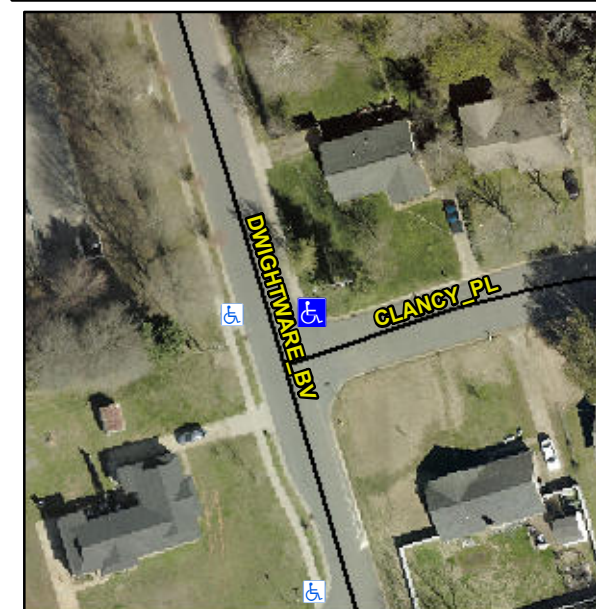
Not Found, R304.5.3

Compliance	Description	Data	Compliance	Description	Data
N/A	Ramp Length (in)	53.5	Yes	Ramp Slope (%)	5.3
Yes	Ramp Width (in)	48.0	No	Ramp XSlope (%)	5.2
N/A	Flare Type LT	N/A	N/A	Flare Type RT	N/A
N/A	Flare Slope LT (%)	N/A	N/A	Flare Slope RT (%)	N/A
N/A	Flare Traversable LT?	N/A	N/A	Flare Traversable RT?	N/A
N/A	Landing Length (in)	N/A	N/A	DWS Provided?	N/A
N/A	Landing Width (in)	N/A	N/A	DWS Contrast?	N/A
N/A	Landing Slope (%)	N/A	N/A	DWS Length (in)	N/A
N/A	Landing X Slope (%)	N/A	N/A	DWS Full Width?	N/A
N/A	Landing Curb? (Y/N)	N/A	N/A	DWS Offset (in)	N/A
N/A	Shared Landing?	N/A			
N/A	Gutter Ponding?	N/A	N/A	Gutter Slope (%)	N/A
N/A	Gutter Lip Ht (in)	N/A	N/A	Gutter X Slope (%)	N/A
N/A	Painted X Walk1?	No	N/A	Painted X Walk2?	No
	X Walk 1 Direction	To W		X Walk 2 Direction	To SE
N/A	X Walk 1 Width (in)	N/A	N/A	X Walk 2 Width (in)	N/A
	X Walk 1 Slope (%)	6.6		X Walk 2 Slope (%)	6.1
	X Walk 1 X Slope (%)	3.4		X Walk 2 X Slope (%)	4.6

N/A	Ramp inside XWalk1?	N/A	N/A	Ramp inside XWalk2?	N/A
	Road Slope (%)	3.9	N/A	Clear Space?	N/A
	Road X Slope (%)	9.7	N/A	Clear Space to XWalk (in)	N/A
N/A	Any Obstructions?	N/A	N/A	Storm Grate/Utility Hazard?	N/A
	Obstruction Type			Storm Grate/Utility Type	
		N/A			N/A
		Yes		Surface Condition? (G/P)	Good

Remove & Replace Curb Ramp With Two New Directional Ramps or Equivalent.
