# Access Compliance Report

## Public Rights-of-Way

### (Curb Ramps)

| Intersection ID: N/A | Main Street: WAVERLY_WALK_AV | Cross Street: HONEYMEADE_CIR | Location: NE |

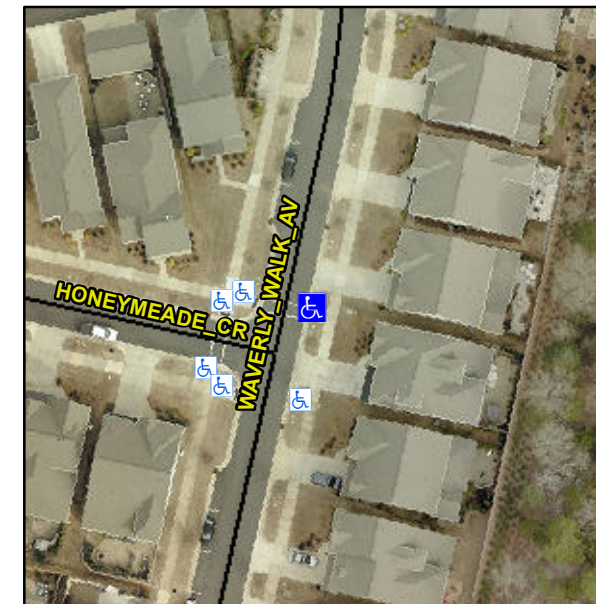
| ADA ID: 446FAD4B7B60 | Ramp Type: Perp | Initial Pass/Fail: Fail | Overall Compliance: No |
| Severity Score: 12.5 | | | |

**Not Found, R304.2.2**

| Compliance | Description | Data | Compliance | Description | Data |
|---|---|---|---|---|---|
| N/A | Ramp Length (in) | 95.0 | No | Ramp Slope (%) | 9.4 |

**Remove & Replace Entire Ramp.**
