Access Compliance Report

Public Rights-of-Way

(Curb Ramps)

Intersection ID: 50585	Main Street: GRAND_FIR_RD	Cross Street: BENDING_BRANCH_RD	Location: NW
ADA ID: 447138AC3341	Ramp Type: Perp	Initial Pass/Fail: Fail	Overall Compliance: No
Severity Score: 21.25			
Codes/Mitigation Info/Possible Solution		Field Measurements/Component Compliance

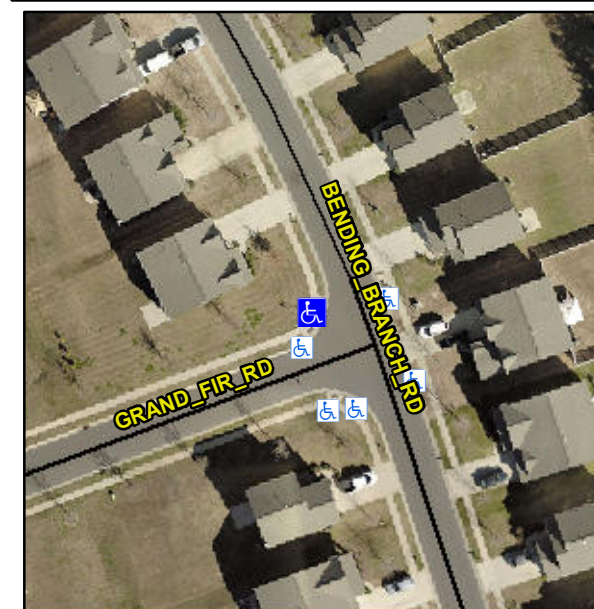
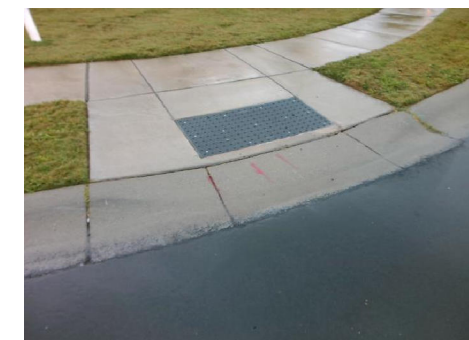
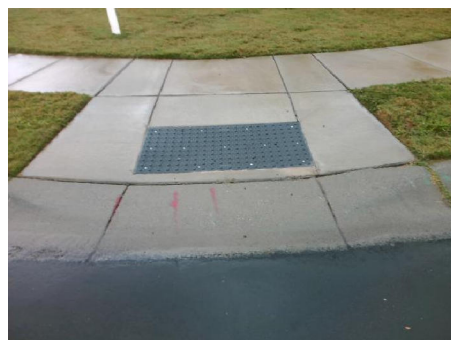
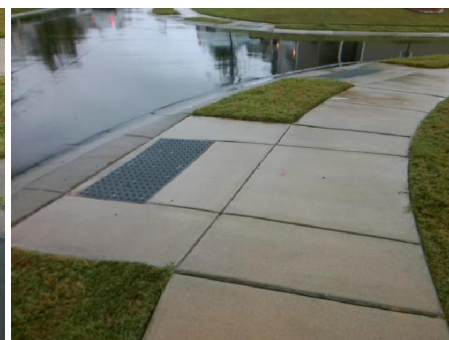
Not Found, R304.5.1, R304.2.2

Compliance	Description	Data	Compliance	Description	Data
N/A	Ramp Length (in)	51.5	No	Ramp Slope (%)	11.1
No	Ramp Width (in)	46.5	Yes	Ramp XSlope (%)	1.9
N/A	Flare Type LT	N/A	N/A	Flare Type RT	N/A
N/A	Flare Slope LT (%)	N/A	N/A	Flare Slope RT (%)	N/A
N/A	Flare Traversable LT?	N/A	N/A	Flare Traversable RT?	N/A
N/A	Landing Length (in)	N/A	N/A	DWS Provided?	N/A
N/A	Landing Width (in)	N/A	N/A	DWS Contrast?	N/A
N/A	Landing Slope (%)	N/A	N/A	DWS Length (in)	N/A
N/A	Landing X Slope (%)	N/A	N/A	DWS Full Width?	N/A
N/A	Landing Curb? (Y/N)	N/A	N/A	DWS Offset (in)	N/A
N/A	Shared Landing?	N/A			
N/A	Gutter Ponding?	N/A	N/A	Gutter Slope (%)	N/A
N/A	Gutter Lip Ht (in)	N/A	N/A	Gutter X Slope (%)	N/A
N/A	Painted X Walk1?	No	N/A	Painted X Walk2?	N/A
	X Walk 1 Direction	To E		X Walk 2 Direction	N/A
N/A	X Walk 1 Width (in)	N/A	N/A	X Walk 2 Width (in)	N/A
	X Walk 1 Slope (%)	1.8		X Walk 2 Slope (%)	N/A
	X Walk 1 X Slope (%)	2.7		X Walk 2 X Slope (%)	N/A

N/A	Ramp inside XWalk1?	N/A	N/A	Ramp inside XWalk2?	N/A
	Road Slope (%)	N/A	N/A	Clear Space?	N/A
	Road X Slope (%)	N/A	N/A	Clear Space to XWalk (in)	N/A
N/A	Any Obstructions?	N/A	N/A	Storm Grate/Utility Hazard?	N/A
	Obstruction Type			Storm Grate/Utility Type	
		N/A			N/A
			Yes	Surface Condition? (G/P)	Good

Remove & Replace Entire Ramp.
