Access Compliance Report

Public Rights-of-Way

(Curb Ramps)

Intersection ID: 31765	Main Street: FIRST_RUN_CT	Cross Street: PINYON_PINE_LN	Location: S
ADA ID: 4471AF8EF257	Ramp Type: Combination2	Initial Pass/Fail: Fail	Overall Compliance: No
			Severity Score: 58.75

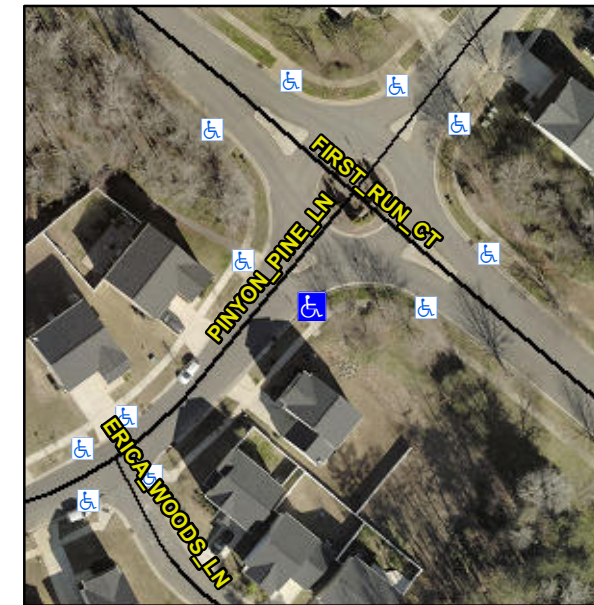
RT RP < 5%

Not Found, R304.2.2, R304.5.3, R304.3.2

Compliance	Description	Data	Compliance	Description	Data
N/A	Ramp Length LT (in)	46.0	N/A	Ramp Length RT (in)	54.5
Yes	Ramp Width LT (in)	49.0	N/A	Ramp Width RT (in)	47.0
No	Ramp Slope LT (%)	13.0	N/A	Ramp Slope RT (%)	2.0
No	Ramp XSlope LT (%)	3.2	N/A	Ramp XSlope RT (%)	8.5
N/A	Ramp Length (in)	83.5	No	Ramp Slope (%)	9.3
Yes	Ramp Width (in)	48.0	No	Ramp XSlope (%)	7.8
N/A	Flare Type LT	N/A	N/A	Flare Type RT	N/A
N/A	Flare Slope LT (%)	N/A	N/A	Flare Slope RT (%)	N/A
N/A	Flare Traversable LT?	N/A	N/A	Flare Traversable RT?	N/A
N/A	Landing Length (in)	N/A	N/A	DWS Provided?	N/A
N/A	Landing Width (in)	N/A	N/A	DWS Contrast?	N/A
N/A	Landing Slope (%)	N/A	N/A	DWS Length (in)	N/A
N/A	Landing X Slope (%)	N/A	N/A	DWS Full Width?	N/A
N/A	Landing Curb? (Y/N)	N/A	N/A	DWS Offset (in)	N/A
N/A	Shared Landing?	N/A			
N/A	Gutter Ponding?	N/A	N/A	Gutter Slope (%)	N/A
N/A	Gutter Lip Ht (in)	N/A	N/A	Gutter X Slope (%)	N/A
N/A	Painted X Walk1?	No	N/A	Painted X Walk2?	N/A

X Walk 1 Direction	To NW		X Walk 2 Direction	N/A
	X Walk 1 Width (in)	N/A		X Walk 2 Width (in)	N/A
	X Walk 1 Slope (%)	4.9		X Walk 2 Slope (%)	N/A
	X Walk 1 X Slope (%)	5.4		X Walk 2 X Slope (%)	N/A
N/A	Ramp inside XWalk1?	N/A	N/A	Ramp inside XWalk2?	N/A
	Road Slope (%)	N/A		Clear Space?	N/A
	Road X Slope (%)	N/A	N/A	Clear Space to XWalk (in)	N/A
			N/A	Any Obstruction?	N/A
				Obstruction Type	N/A
			N/A	Storm Grate/Utility Hazard?	N/A
				Storm Grate/Utility Type	N/A
					N/A
Yes	Surface Condition? (G/P)	Good			
	Curb Slope (%)	12.6

Remove & Replace Entire Ramp.
