# Access Compliance Report

## Public Rights-of-Way

### (Curb Ramps)

Intersection ID: 42593	Main Street: W_MOREHEAD_ST	Cross Street: W_JOHN_BELK_RA	Location: SE
ADA ID: 44750915A564	Ramp Type: Perp	Initial Pass/Fail: Fail	Overall Compliance: No
Severity Score: 46.25			
Codes/Mitigation Info/Possible Solution		Field Measurements/Component Compliance

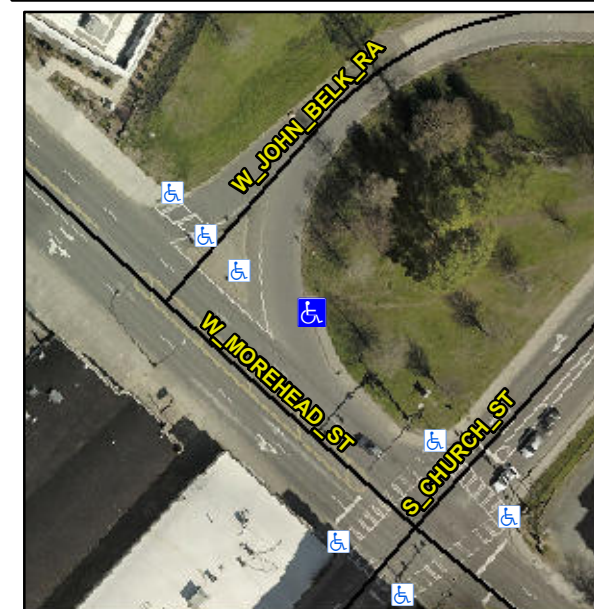
**Not Found, R304.5.1, R304.2.2, R304.5.3**

Compliance	Description	Data	Compliance	Description	Data
N/A	Ramp Length (in)	62.0	No	Ramp Slope (%)	15.9
No	Ramp Width (in)	45.0	No	Ramp XSlope (%)	6.9
N/A	Flare Type LT	N/A	N/A	Flare Type RT	N/A
N/A	Flare Slope LT (%)	N/A	N/A	Flare Slope RT (%)	N/A
N/A	Flare Traversable LT?	N/A	N/A	Flare Traversable RT?	N/A
N/A	Landing Length (in)	N/A	N/A	DWS Provided?	N/A
N/A	Landing Width (in)	N/A	N/A	DWS Contrast?	N/A
N/A	Landing Slope (%)	N/A	N/A	DWS Length (in)	N/A
N/A	Landing X Slope (%)	N/A	N/A	DWS Full Width?	N/A
N/A	Landing Curb? (Y/N)	N/A	N/A	DWS Offset (in)	N/A
N/A	Shared Landing?	N/A			
N/A	Gutter Ponding?	N/A	N/A	Gutter Slope (%)	N/A
N/A	Gutter Lip Ht (in)	N/A	N/A	Gutter X Slope (%)	N/A
N/A	Painted X Walk1?	No	N/A	Painted X Walk2?	N/A
	X Walk 1 Direction	To NW		X Walk 2 Direction	N/A
N/A	X Walk 1 Width (in)	N/A	N/A	X Walk 2 Width (in)	N/A
	X Walk 1 Slope (%)	2.8		X Walk 2 Slope (%)	N/A
	X Walk 1 X Slope (%)	7.9		X Walk 2 X Slope (%)	N/A

N/A	Ramp inside XWalk1?	N/A	N/A	Ramp inside XWalk2?	N/A
	Road Slope (%)	N/A	N/A	Clear Space?	N/A
	Road X Slope (%)	N/A	N/A	Clear Space to XWalk (in)	N/A
N/A	Any Obstructions?	N/A	N/A	Storm Grate/Utility Hazard?	N/A
	Obstruction Type			Storm Grate/Utility Type	
		N/A			N/A
		Yes		Surface Condition? (G/P)	Good

**Remove & Replace Entire Ramp.**

Total Cost: \$ 1850.00
