Access Compliance Report

Public Rights-of-Way

(Curb Ramps)

Intersection ID: 15287	Main Street: ALBEMARLE_RD	Cross Street: N_SHARON_AMITY_RD	Location: SE
ADA ID: 4478BDBD4A6E	Ramp Type: Para	Initial Pass/Fail: Pass	Overall Compliance: No
Codes/Mitigation Info/Possible Solution		Field Measurements/Component Compliance	
Severity Score: 0.25

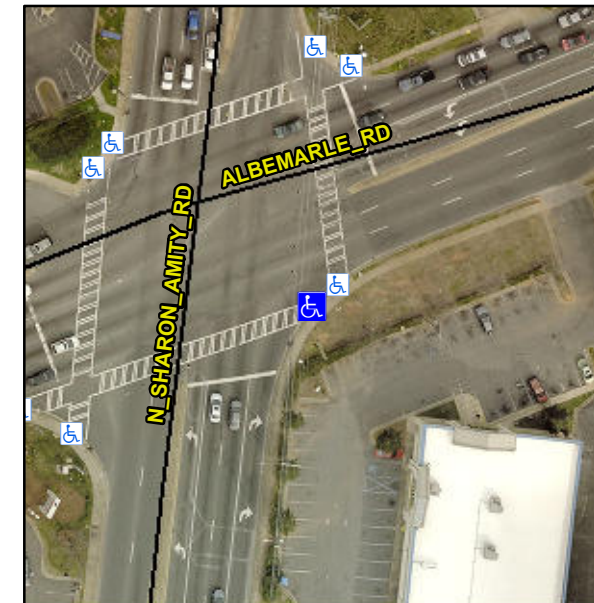
LT RP < 5%

**R304.5.3, R304.2.1, R304.2.2-Perp,
R304.3.2-Para**

Compliance	Description	Data	Compliance	Description	Data
N/A	Ramp Length LT (in)	66.0	N/A	Ramp Length RT (in)	69.5
Yes	Ramp Width LT (in)	70.0	Yes	Ramp Width RT (in)	66.0
Yes	Ramp Slope LT (%)	3.1	Yes	Ramp Slope RT (%)	7.7
No	Ramp XSlope LT (%)	3.5	No	Ramp XSlope RT (%)	3.4
Yes	Landing Length (in)	70.0	Yes	DWS Provided?	Yes
No	Landing Width (in)	45.5	Yes	DWS Contrast?	Yes
No	Landing Slope (%)	3.0	Yes	DWS Length (in)	24.5
Yes	Landing X Slope (%)	2.2	Yes	DWS Full Width?	Yes
N/A	Landing Curb? (Y/N)	No	Yes	DWS Offset (in)	1.0
N/A	Shared Landing?	No			
Yes	Gutter Ponding?	No	Yes	Gutter Slope (%)	2.5
Yes	Gutter Lip Ht (in)	0.0	Yes	Gutter X Slope (%)	2.2
N/A	Painted X Walk1?	Yes	N/A	Painted X Walk2?	N/A
	X Walk 1 Direction	To W		X Walk 2 Direction	N/A
N/A	X Walk 1 Width (in)	110.0	N/A	X Walk 2 Width (in)	N/A
	X Walk 1 Slope (%)	0.3		X Walk 2 Slope (%)	N/A
	X Walk 1 X Slope (%)	2.9		X Walk 2 X Slope (%)	N/A
Yes	Ramp inside XWalk1?	Yes	N/A	Ramp inside XWalk2?	N/A

Road Slope (%)	N/A	N/A	Clear Space?	Yes
	Road X Slope (%)	N/A	N/A	Clear Space to XWalk (in)	N/A
Yes	Any Obstructions?	No	Yes	Storm Grate/Utility Hazard?	No
	Obstruction Type			Storm Grate/Utility Type	
		N/A			N/A
			Yes	Surface Condition? (G/P)	Good
			N/A	Curb Slope (%)	29.6

Remove & Replace Entire Ramp.
