# Access Compliance Report

## Public Rights-of-Way

### (Curb Ramps)

| Intersection ID: 45494 | Main Street: BUGGY_HORSE_RD | Cross Street: COTTON_STAND_RD | Location: SE |

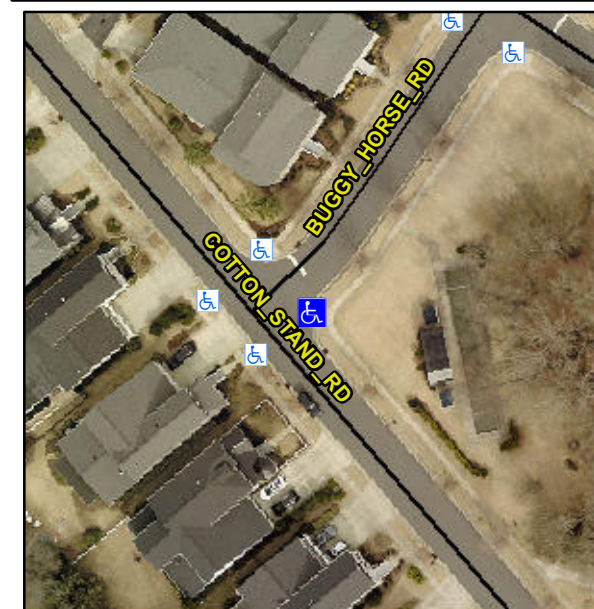
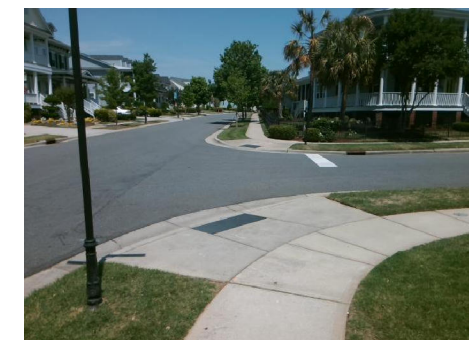
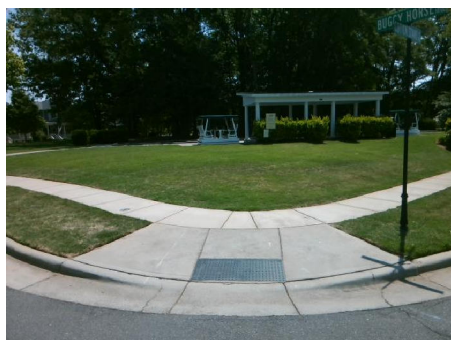
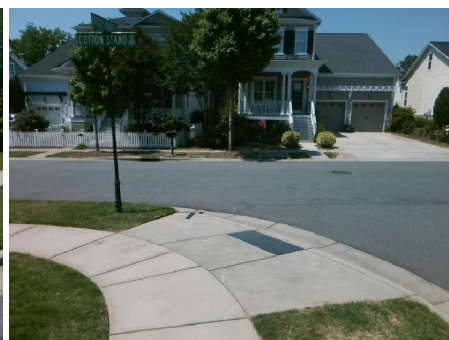
**Not Found, R304.2.2-Perp, R304.3.2-Para, R304.5.3, R304.5.4**

| Compliance | Description | Data | Compliance | Description | Data |
|---|---|---|---|---|---|
| No | Landing Slope (%) | 2.9 | Yes | DWS Length (in) | 24.5 |
| No | Landing X Slope (%) | 4.0 | Yes | DWS Full Width? | Yes |
| Yes | Gutter Ponding? | No | No | Gutter Slope (%) | 12.3 |

**Remove & Replace Curb Ramp With Two New Directional Ramps or Equivalent. Remove & Replace Gutter.**
