# Access Compliance Report

## Public Rights-of-Way

### (Curb Ramps)

Intersection ID: 29721	Main Street: COLE_MILL_RD	Cross Street: LANNIER_FALLS_LN	Location: NW
ADA ID: 4483DEA46F8D	Ramp Type: PerpDiag	Initial Pass/Fail: Fail	Overall Compliance: No
			Severity Score: 13.75

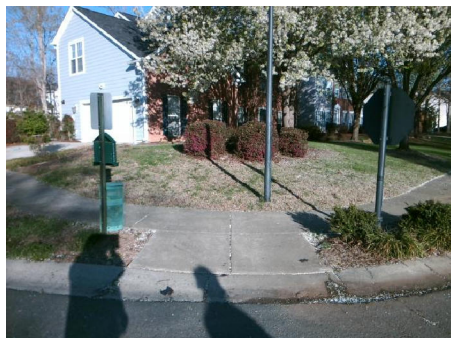
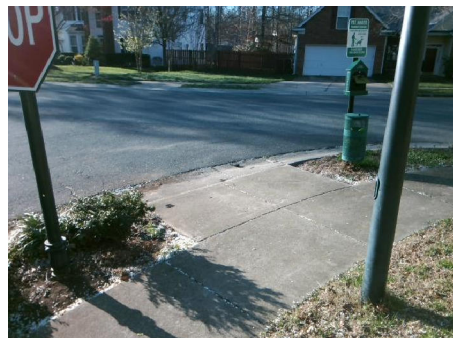
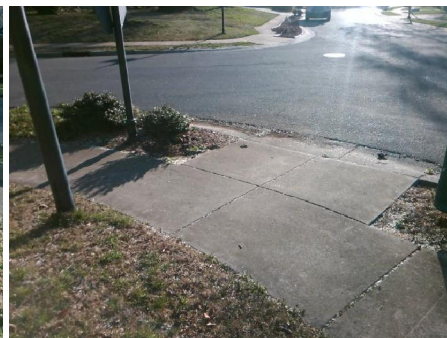
Compliance	Description	Data	Compliance	Description	Data
N/A	Ramp Length (in)	49.0	No	Ramp Slope (%)	9.1
Yes	Ramp Width (in)	48.0	No	Ramp XSlope (%)	4.0
N/A	Flare Type LT	N/A	N/A	Flare Type RT	N/A
N/A	Flare Slope LT (%)	N/A	N/A	Flare Slope RT (%)	N/A
N/A	Flare Traversable LT?	N/A	N/A	Flare Traversable RT?	N/A
N/A	Landing Length (in)	N/A	N/A	DWS Provided?	N/A
N/A	Landing Width (in)	N/A	N/A	DWS Contrast?	N/A
N/A	Landing Slope (%)	N/A	N/A	DWS Length (in)	N/A
N/A	Landing X Slope (%)	N/A	N/A	DWS Full Width?	N/A
N/A	Landing Curb? (Y/N)	N/A	N/A	DWS Offset (in)	N/A
N/A	Shared Landing?	N/A			
N/A	Gutter Ponding?	N/A	N/A	Gutter Slope (%)	N/A
N/A	Gutter Lip Ht (in)	N/A	N/A	Gutter X Slope (%)	N/A
N/A	Painted X Walk1?	No	N/A	Painted X Walk2?	No
	X Walk 1 Direction	To S		X Walk 2 Direction	To E
N/A	X Walk 1 Width (in)	N/A	N/A	X Walk 2 Width (in)	N/A
	X Walk 1 Slope (%)	3.7		X Walk 2 Slope (%)	1.0
	X Walk 1 X Slope (%)	3.0		X Walk 2 X Slope (%)	0.5

N/A	Ramp inside XWalk1?	N/A	N/A	Ramp inside XWalk2?	N/A
	Road Slope (%)	1.6	N/A	Clear Space?	N/A
	Road X Slope (%)	0.7	N/A	Clear Space to XWalk (in)	N/A
N/A	Any Obstructions?	N/A	N/A	Storm Grate/Utility Hazard?	N/A
	Obstruction Type			Storm Grate/Utility Type	
		N/A			N/A
			Yes	Surface Condition? (G/P)	Good

**Remove & Replace Curb Ramp With Two New Directional Ramps or Equivalent.**

**R304.2.2, R304.5.3**
