Access Compliance Report

Public Rights-of-Way

(Curb Ramps)

Intersection ID: 32194	Main Street: BLAKEWOOD_DR	Cross Street: CHELTON_RIDGE_LN	Location: NE
ADA ID: 448B04448EB5	Ramp Type: Perp	Initial Pass/Fail: Fail	Overall Compliance: No
Codes/Mitigation Info/Possible Solution		Field Measurements/Component Compliance	
Severity Score: 21.25

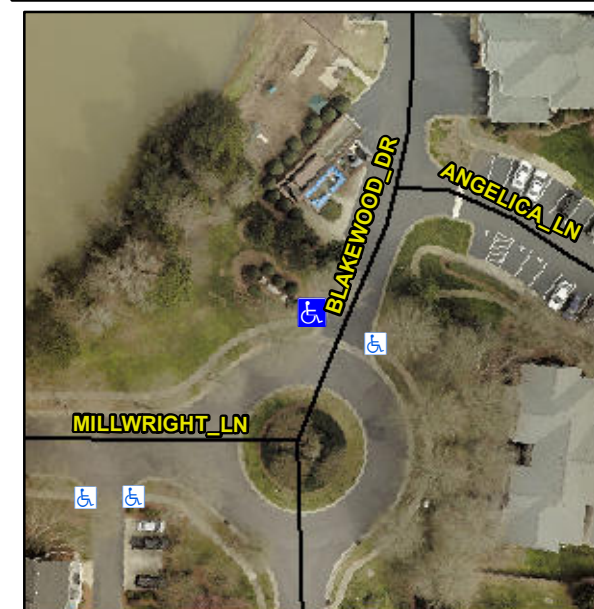
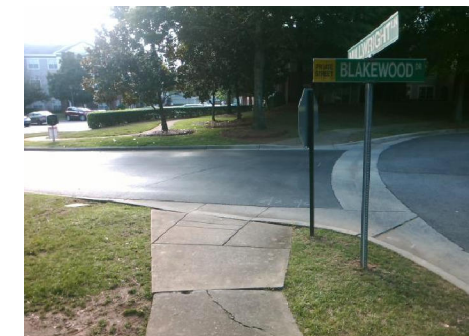
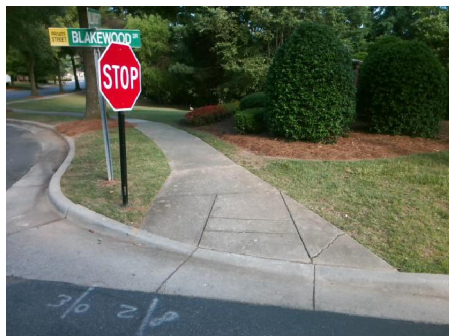
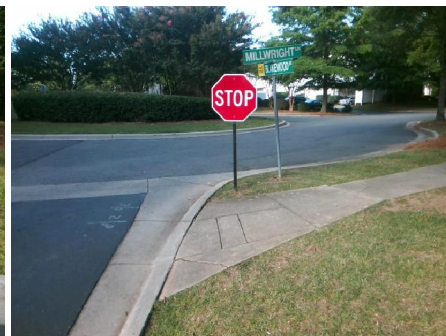
R304.5.1, R304.2.2

Compliance	Description	Data	Compliance	Description	Data
N/A	Ramp Length (in)	94.0	No	Ramp Slope (%)	10.8
No	Ramp Width (in)	36.0	Yes	Ramp XSlope (%)	1.1
N/A	Flare Type LT	N/A	N/A	Flare Type RT	N/A
N/A	Flare Slope LT (%)	N/A	N/A	Flare Slope RT (%)	N/A
N/A	Flare Traversable LT?	N/A	N/A	Flare Traversable RT?	N/A
N/A	Landing Length (in)	N/A	N/A	DWS Provided?	N/A
N/A	Landing Width (in)	N/A	N/A	DWS Contrast?	N/A
N/A	Landing Slope (%)	N/A	N/A	DWS Length (in)	N/A
N/A	Landing X Slope (%)	N/A	N/A	DWS Full Width?	N/A
N/A	Landing Curb? (Y/N)	N/A	N/A	DWS Offset (in)	N/A
N/A	Shared Landing?	N/A			
N/A	Gutter Ponding?	N/A	N/A	Gutter Slope (%)	N/A
N/A	Gutter Lip Ht (in)	N/A	N/A	Gutter X Slope (%)	N/A
N/A	Painted X Walk1?	No	N/A	Painted X Walk2?	N/A
	X Walk 1 Direction	To SE		X Walk 2 Direction	N/A
N/A	X Walk 1 Width (in)	N/A	N/A	X Walk 2 Width (in)	N/A
	X Walk 1 Slope (%)	2.2		X Walk 2 Slope (%)	N/A
	X Walk 1 X Slope (%)	3.5		X Walk 2 X Slope (%)	N/A

N/A	Ramp inside XWalk1?	N/A	N/A	Ramp inside XWalk2?	N/A
	Road Slope (%)	N/A	N/A	Clear Space?	N/A
	Road X Slope (%)	N/A	N/A	Clear Space to XWalk (in)	N/A
N/A	Any Obstructions?	N/A	N/A	Storm Grate/Utility Hazard?	N/A
	Obstruction Type			Storm Grate/Utility Type	
		N/A			N/A
			Yes	Surface Condition? (G/P)	Good

Remove & Replace Entire Ramp.

Total Cost: \$ 1850.00
