# Access Compliance Report

## Public Rights-of-Way

### (Curb Ramps)

Intersection ID: N/A	Main Street: I-77_EXIT	Cross Street: W_T_HARRIS_BV	Location: NW
ADA ID: 448EC7E1A82B	Ramp Type: Para	Initial Pass/Fail: Fail	Overall Compliance: No
Severity Score: 12.5			
Codes/Mitigation Info/Possible Solution		Field Measurements/Component Compliance

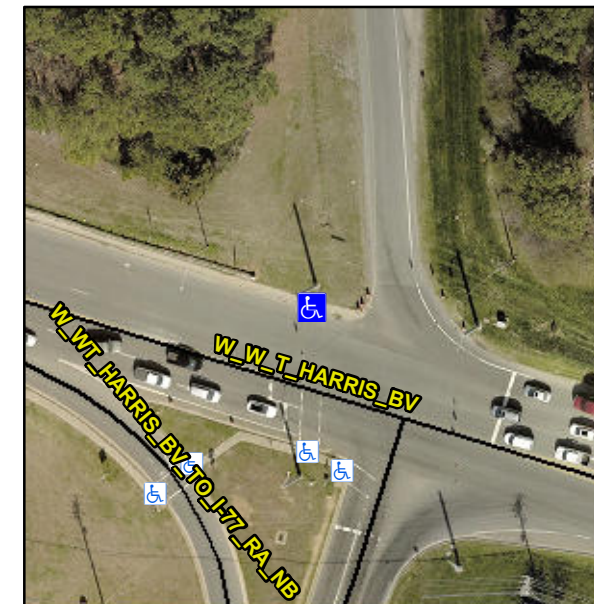
**DEBRIS COVERING RAMP**

Compliance	Description	Data	Compliance	Description	Data
N/A	Ramp Length LT (in)	71.0	N/A	Ramp Length RT (in)	69.0
Yes	Ramp Width LT (in)	48.0	Yes	Ramp Width RT (in)	48.0
No	Ramp Slope LT (%)	11.7	No	Ramp Slope RT (%)	8.5
Yes	Ramp XSlope LT (%)	0.1	Yes	Ramp XSlope RT (%)	0.9
N/A	Landing Length (in)	N/A	N/A	DWS Provided?	N/A
N/A	Landing Width (in)	N/A	N/A	DWS Contrast?	N/A
N/A	Landing Slope (%)	N/A	N/A	DWS Length (in)	N/A
N/A	Landing X Slope (%)	N/A	N/A	DWS Full Width?	N/A
N/A	Landing Curb? (Y/N)	N/A	N/A	DWS Offset (in)	N/A
N/A	Shared Landing?	N/A			
N/A	Gutter Ponding?	N/A	N/A	Gutter Slope (%)	N/A
N/A	Gutter Lip Ht (in)	N/A	N/A	Gutter X Slope (%)	N/A
N/A	Painted X Walk1?	Yes	N/A	Painted X Walk2?	N/A
	X Walk 1 Direction	To S		X Walk 2 Direction	N/A
N/A	X Walk 1 Width (in)	111.0	N/A	X Walk 2 Width (in)	N/A
	X Walk 1 Slope (%)	0.7		X Walk 2 Slope (%)	N/A
	X Walk 1 X Slope (%)	1.4		X Walk 2 X Slope (%)	N/A
N/A	Ramp inside XWalk1?	Yes	N/A	Ramp inside XWalk2?	N/A

Road Slope (%)	N/A	N/A	Clear Space?	N/A
	Road X Slope (%)	N/A	N/A	Clear Space to XWalk (in)	N/A
N/A	Any Obstructions?	N/A	N/A	Storm Grate/Utility Hazard?	N/A
	Obstruction Type			Storm Grate/Utility Type	
		N/A			N/A
			Yes	Surface Condition? (G/P)	Good
			N/A	Curb Slope (%)	2.7

Possible Solutions:

**Remove & Replace Entire Ramp.**
