Access Compliance Report

Public Rights-of-Way

(Curb Ramps)

Intersection ID: 54301	Main Street: GOLF_LINKS_DR	Cross Street: PROVIDENCE_FARM_LN	Location: SE
ADA ID: 449A61EA6C83	Ramp Type: Perp	Initial Pass/Fail: Fail	Overall Compliance: No
Severity Score: 12.5			
Codes/Mitigation Info/Possible Solution		Field Measurements/Component Compliance

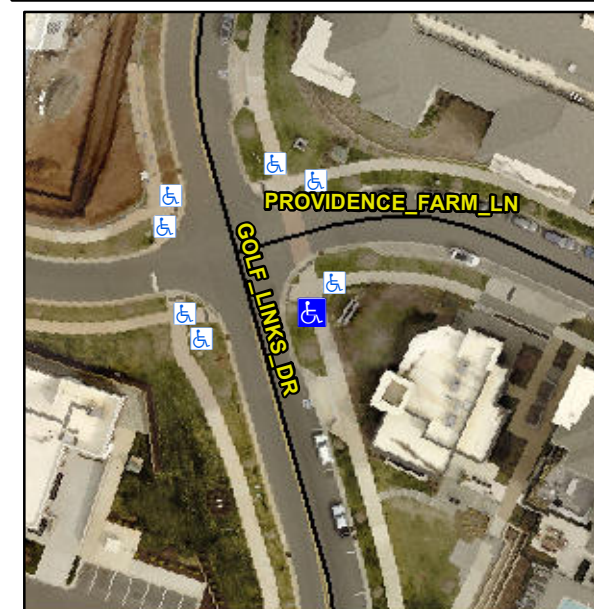
Not Found, R304.2.2

Compliance	Description	Data	Compliance	Description	Data
N/A	Ramp Length (in)	88.0	No	Ramp Slope (%)	9.0
Yes	Ramp Width (in)	89.0	Yes	Ramp XSlope (%)	1.9
N/A	Flare Type LT	N/A	N/A	Flare Type RT	N/A
N/A	Flare Slope LT (%)	N/A	N/A	Flare Slope RT (%)	N/A
N/A	Flare Traversable LT?	N/A	N/A	Flare Traversable RT?	N/A
N/A	Landing Length (in)	N/A	N/A	DWS Provided?	N/A
N/A	Landing Width (in)	N/A	N/A	DWS Contrast?	N/A
N/A	Landing Slope (%)	N/A	N/A	DWS Length (in)	N/A
N/A	Landing X Slope (%)	N/A	N/A	DWS Full Width?	N/A
N/A	Landing Curb? (Y/N)	N/A	N/A	DWS Offset (in)	N/A
N/A	Shared Landing?	N/A			
N/A	Gutter Ponding?	N/A	N/A	Gutter Slope (%)	N/A
N/A	Gutter Lip Ht (in)	N/A	N/A	Gutter X Slope (%)	N/A
N/A	Painted X Walk1?	No	N/A	Painted X Walk2?	N/A
	X Walk 1 Direction	To W		X Walk 2 Direction	N/A
N/A	X Walk 1 Width (in)	N/A	N/A	X Walk 2 Width (in)	N/A
	X Walk 1 Slope (%)	2.6		X Walk 2 Slope (%)	N/A
	X Walk 1 X Slope (%)	1.4		X Walk 2 X Slope (%)	N/A

N/A	Ramp inside XWalk1?	N/A	N/A	Ramp inside XWalk2?	N/A
	Road Slope (%)	N/A	N/A	Clear Space?	N/A
	Road X Slope (%)	N/A	N/A	Clear Space to XWalk (in)	N/A
N/A	Any Obstructions?	N/A	N/A	Storm Grate/Utility Hazard?	N/A
	Obstruction Type			Storm Grate/Utility Type	
		N/A			N/A
			Yes	Surface Condition? (G/P)	Good

Remove & Replace Entire Ramp.

Total Cost: \$ 1850.00
