# Access Compliance Report

## Public Rights-of-Way

### (Curb Ramps)

| Intersection ID: 3829 | Main Street: BROWNE'S_FERRY_RD | Cross Street: KINSMORE_LN | Location: | N |

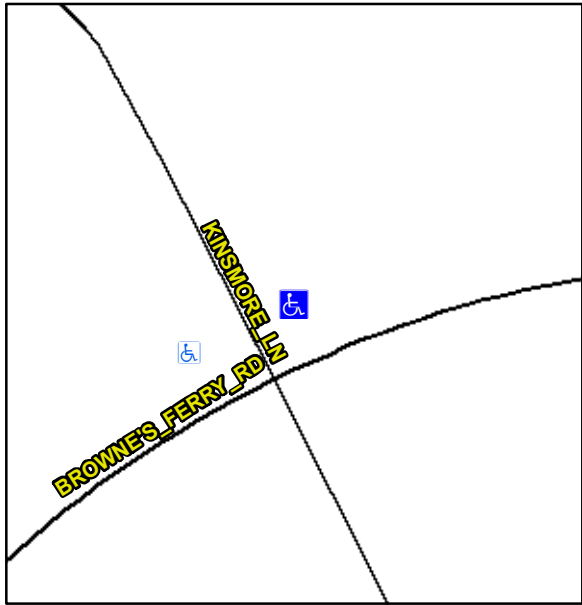
| ADA ID: 449B0EC010E9 | Ramp Type: Directional1 | Initial Pass/Fail: Fail | Overall Compliance: No | Severity Score: 13.75 |

| Codes/Mitigation Info/Possible Solution | | | Field Measurements/Component Compliance | | | | | |
|---|---|---|---|---|---|---|---|---|
| | | | No | Ramp Slope (%) | 10.6 | N/A | Grade Break XSlope (%) | 0.0 |
| | | | No | Ramp XSlope (%) | 3.1 | | | |
| | R304.2.2, R304.5.3 | | N/A | Shared Landing? | N/A | N/A | DWS Offset RT (in) | N/A |

| Codes/Mitigation Info/Possible Solution | | | Field Measurements/Component Compliance | | | | | |
|---|---|---|---|---|---|---|---|---|
| | Remove & Replace Entire Ramp. | | N/A | Ramp Length (in) | 73.0 | N/A | Grade Break? | N/A |
