Access Compliance Report

Public Rights-of-Way

(Curb Ramps)

Intersection ID: N/A	Main Street: PROVIDENCE_RD	Cross Street: RAINTREE_LN	Location: SW
ADA ID: 449B30259F2B	Ramp Type: PerpDiag	Initial Pass/Fail: Fail	Overall Compliance: No
Codes/Mitigation Info/Possible Solution		Field Measurements/Component Compliance	
Severity Score: 18.75

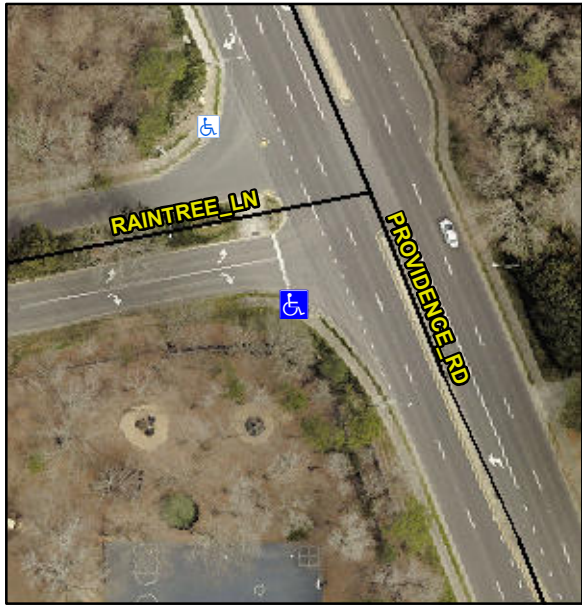
Compliance	Description	Data	Compliance	Description	Data
N/A	Ramp Length (in)	77.0	Yes	Ramp Slope (%)	7.6
No	Ramp Width (in)	32.0	No	Ramp XSlope (%)	3.9
N/A	Flare Type LT	N/A	N/A	Flare Type RT	N/A
N/A	Flare Slope LT (%)	N/A	N/A	Flare Slope RT (%)	N/A
N/A	Flare Traversable LT?	N/A	N/A	Flare Traversable RT?	N/A
N/A	Landing Length (in)	N/A	N/A	DWS Provided?	N/A
N/A	Landing Width (in)	N/A	N/A	DWS Contrast?	N/A
N/A	Landing Slope (%)	N/A	N/A	DWS Length (in)	N/A
N/A	Landing X Slope (%)	N/A	N/A	DWS Full Width?	N/A
N/A	Landing Curb? (Y/N)	N/A	N/A	DWS Offset (in)	N/A
N/A	Shared Landing?	N/A			
N/A	Gutter Ponding?	N/A	N/A	Gutter Slope (%)	N/A
N/A	Gutter Lip Ht (in)	N/A	N/A	Gutter X Slope (%)	N/A
N/A	Painted X Walk1?	No	N/A	Painted X Walk2?	No
	X Walk 1 Direction	To E		X Walk 2 Direction	To NW
N/A	X Walk 1 Width (in)	N/A	N/A	X Walk 2 Width (in)	N/A
	X Walk 1 Slope (%)	2.6		X Walk 2 Slope (%)	1.5
	X Walk 1 X Slope (%)	2.1		X Walk 2 X Slope (%)	4.4

N/A	Ramp inside XWalk1?	N/A	N/A	Ramp inside XWalk2?	N/A
	Road Slope (%)	3.3	N/A	Clear Space?	N/A
	Road X Slope (%)	2.5	N/A	Clear Space to XWalk (in)	N/A
N/A	Any Obstructions?	N/A	N/A	Storm Grate/Utility Hazard?	N/A
	Obstruction Type			Storm Grate/Utility Type	
		N/A			N/A
			Yes	Surface Condition? (G/P)	Good

Possible Solutions:

Remove & Replace Curb Ramp With Two New Directional Ramps or Equivalent.

R304.5.1, R304.5.3
