# Access Compliance Report

## Public Rights-of-Way

### (Curb Ramps)

| Intersection ID: 20540 | Main Street: FAIRVIEW_RD | Cross Street: VALENCIA_TR | Location: NE |

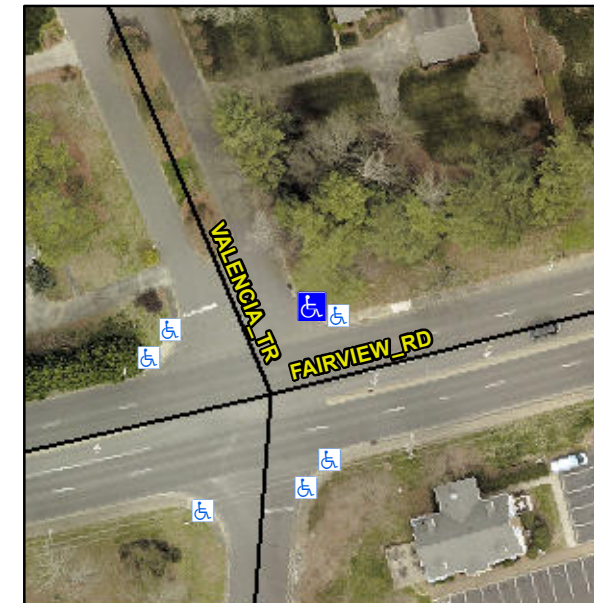
| ADA ID: 449BBAE7CDCE | Ramp Type: Perp | Initial Pass/Fail: Pass | Overall Compliance: No |
| | | Severity Score: 10 | |

**Not Found, R304.2.1, R304.2.2-Perp, R304.3.2-Para, R304.5.3, R305.2**

| Compliance | Description | Data | Compliance | Description | Data |
|---|---|---|---|---|---|
| No | Landing Length (in) | N/A | Yes | DWS Provided? | Yes |
| No | Landing Width (in) | N/A | Yes | DWS Contrast? | Yes |
| No | Landing Slope (%) | N/A | Yes | DWS Length (in) | 24.0 |
| No | Landing X Slope (%) | N/A | Yes | DWS Full Width? | Yes |
| N/A | Landing Curb? (Y/N) | No | No | DWS Offset (in) | 6.0 |

**Remove & Replace Entire Ramp.**

Total Cost: \$ 1850.00
