Access Compliance Report

Public Rights-of-Way

(Curb Ramps)

Intersection ID: 9380	Main Street: STATESVILLE_AV	Cross Street: DEARBORN_AV	Location: SW
ADA ID: 449DB05786EA	Ramp Type: Directional1	Initial Pass/Fail: Fail	Overall Compliance: No
Severity Score: 1.25			
Codes/Mitigation Info/Possible Solution		Field Measurements/Component Compliance

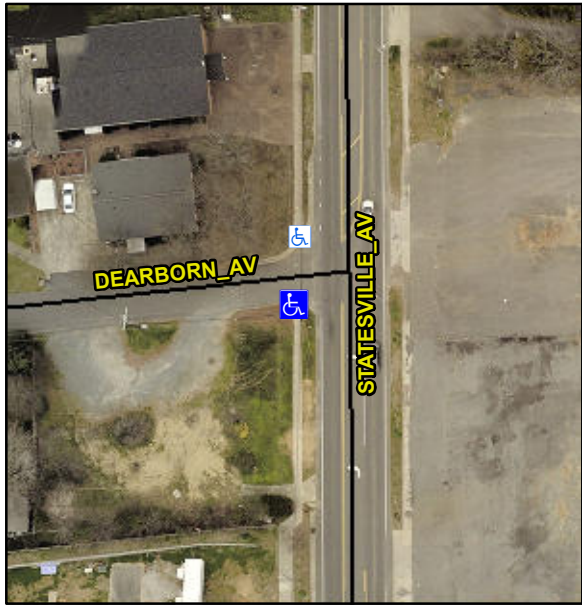
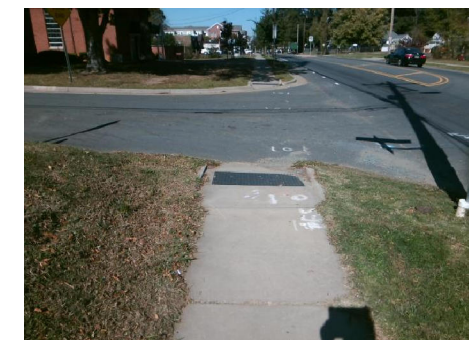
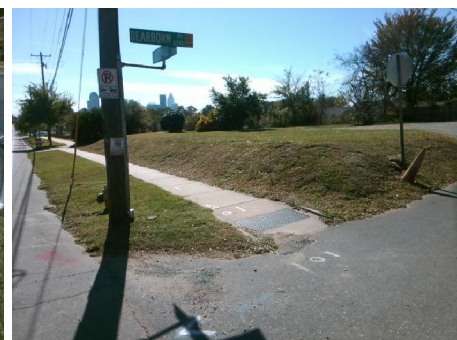
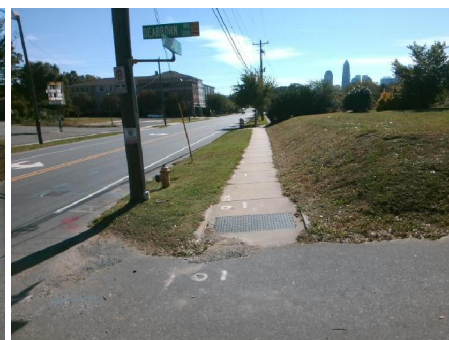
NO CURB

Compliance	Description	Data	Compliance	Description	Data
N/A	Ramp Length (in)	76.0	N/A	Grade Break?	N/A
Yes	Ramp Width (in)	58.0	N/A	Grade Break Slope (%)	0.0
Yes	Ramp Slope (%)	6.8	N/A	Grade Break XSlope (%)	0.0
No	Ramp XSlope (%)	3.8			
N/A	Flare Type LT	N/A	N/A	Flare Type RT	N/A
N/A	Flare Slope LT (%)	N/A	N/A	Flare Slope RT (%)	0.0
N/A	Flare Traversable LT?	N/A	N/A	Flare Traversable RT?	N/A
N/A	Landing Length (in)	0.0	N/A	DWS Provided?	N/A
N/A	Landing Width (in)	0.0	N/A	DWS Contrast?	N/A
N/A	Landing Slope (%)	0.0	N/A	DWS Length (in)	N/A
N/A	Landing X Slope (%)	0.0	N/A	DWS Full Width?	N/A
N/A	Landing Curb? (Y/N)	N/A	N/A	DWS Offset LT (in)	N/A
N/A	Shared Landing?	N/A	N/A	DWS Offset RT (in)	N/A
N/A	Gutter Ponding?	0.0	N/A	Gutter Slope (%)	N/A
N/A	Gutter Lip Ht (in)	0.0	N/A	Gutter X Slope (%)	N/A
N/A	Painted X Walk1?	No		Road Slope (%)	3.4
	X Walk 1 Direction	To N		Road X Slope (%)	5.1
	X Walk 1 Width (in)	N/A		Clear Space?	N/A

X Walk 1 Slope (%)	3.4	N/A	Clear Space to XWalk (in)	N/A
	X Walk 1 X Slope (%)	5.1	N/A	Storm Grate/Utility Hazard?	N/A
N/A	Ramp inside XWalk1?	N/A		Storm Grate/Utility Type	
N/A	Any Obstructions?	N/A			N/A
	Obstruction Type		Yes	Surface Condition? (G/P)	Good
		N/A	N/A	Curb Slope (%)	N/A

Remove & Replace Entire Ramp.
