# Access Compliance Report

## Public Rights-of-Way (Curb Ramps)

| Intersection ID: 11265 | Main Street: N_TRYON_ST | Cross Street: WADSWORTH_PL | Location: W |
| ADA ID: 44AD77A0B634 | Ramp Type: Perp | Initial Pass/Fail: Fail | Overall Compliance: No |

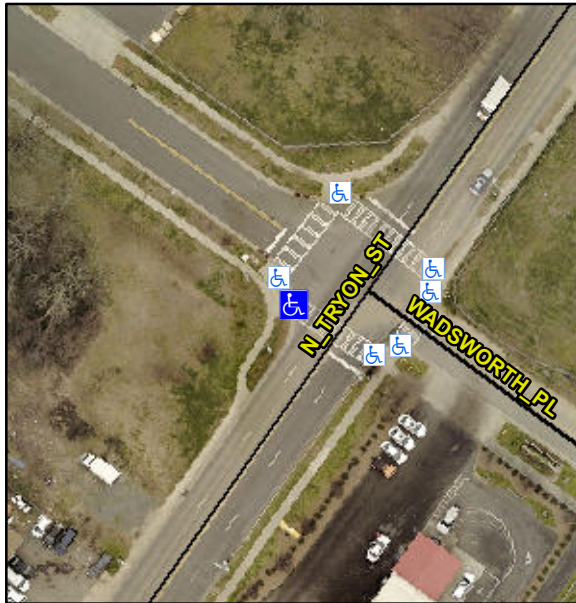
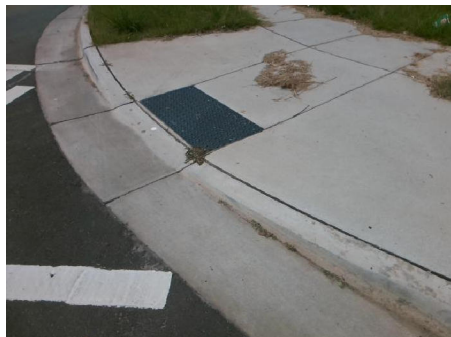
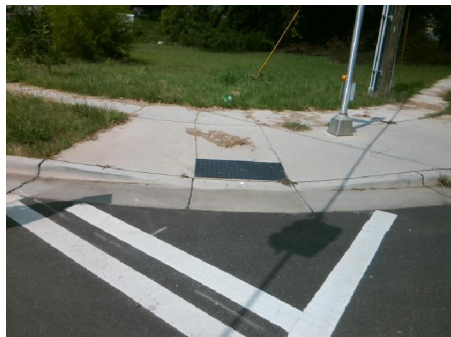
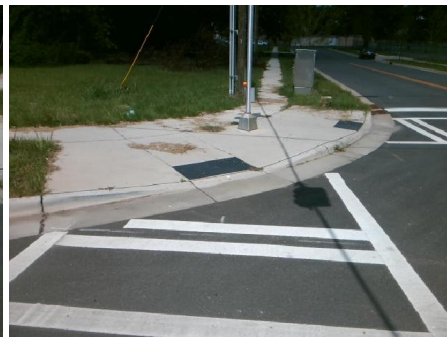
**Not Found, R304.5.1, R304.5.3**

| Compliance | Description | Data | Compliance | Description | Data |
|---|---|---|---|---|---|
| N/A | Ramp Length (in) | 95.0 | Yes | Ramp Slope (%) | 5.2 |
| No | Ramp Width (in) | 46.5 | No | Ramp XSlope (%) | 2.5 |

**Remove & Replace Entire Ramp.**
