# Access Compliance Report

## Public Rights-of-Way

| Intersection ID: 15984 | Main Street: LANIER_AV | Cross Street: UNAKA_AV | Location: SW |
| ADA ID: 44B18643D8F2 | Ramp Type: Directional1 | Initial Pass/Fail: Pass | Overall Compliance: No |

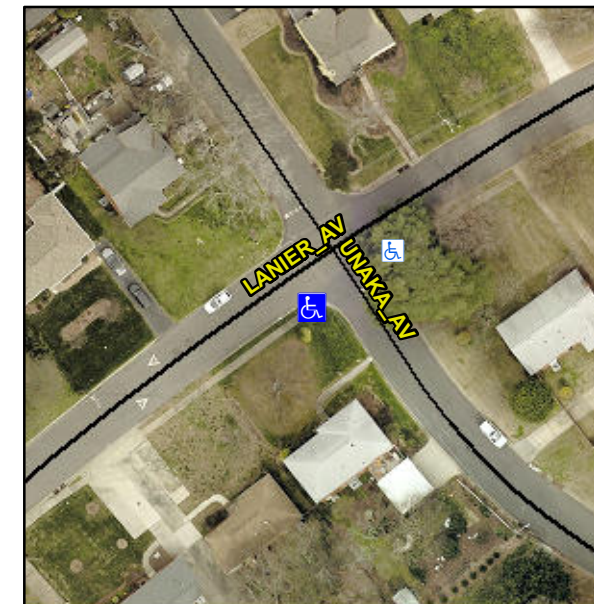
**Not Found, R304.2.2-Perp, R304.3.2-  
Para, R304.5.3, R305.1.4, R305.2,  
R304.5.4**

| Compliance | Description | Data | Compliance | Description | Data |
|---|---|---|---|---|---|
| Yes | Ramp Slope (%) | 2.2 | No | Grade Break XSlope (%) | 3.6 |
| No | Landing Slope (%) | 4.4 | Yes | DWS Length (in) | 24.0 |
| Yes | Landing X Slope (%) | 0.3 | No | DWS Full Width? | No |
| N/A | Shared Landing? | No | No | DWS Offset RT (in) | 4.0 |
| Yes | Gutter Ponding? | No | No | Gutter Slope (%) | 6.2 |
| Yes | Gutter Lip Ht (in) | 0.0 | No | Gutter X Slope (%) | 2.4 |

**Remove & Replace Entire Ramp.  
Remove & Replace Gutter.**
