# Access Compliance Report

## Public Rights-of-Way

| Intersection ID: 50600 | Main Street: BENDING_BRANCH_RD | Cross Street: HEARTLEAF_RD | Location: | N |
| ADA ID: 44C84F0F427C | Ramp Type: Perp | Initial Pass/Fail: Fail | Overall Compliance: No | Severity Score: 25 |

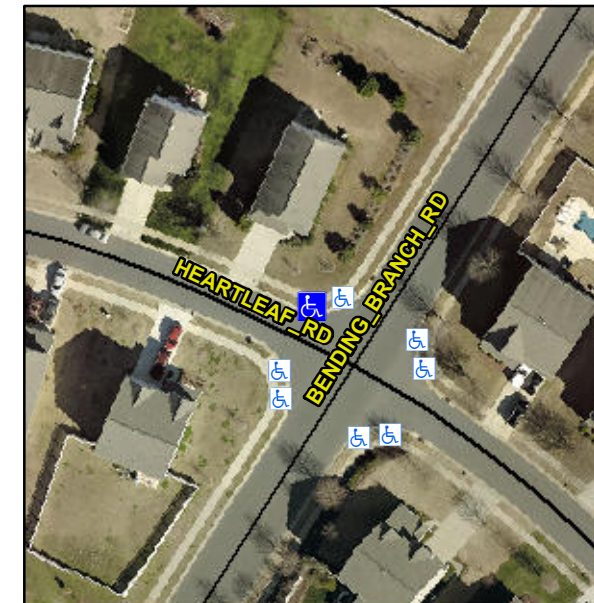
**Not Found, R304.2.2, R304.5.3**

| Compliance | Description | Data | Compliance | Description | Data |
|---|---|---|---|---|---|
| N/A | Ramp Length (in) | 47.0 | No | Ramp Slope (%) | 11.4 |
| Yes | Ramp Width (in) | 48.0 | No | Ramp XSlope (%) | 6.3 |

**Remove & Replace Entire Ramp.**
