Access Compliance Report

Public Rights-of-Way

(Curb Ramps)

| Intersection ID: 31346 | Main Street: COCHRAN_FARM_LN | Cross Street: W_SUGAR_CREEK_RD | Location: E |

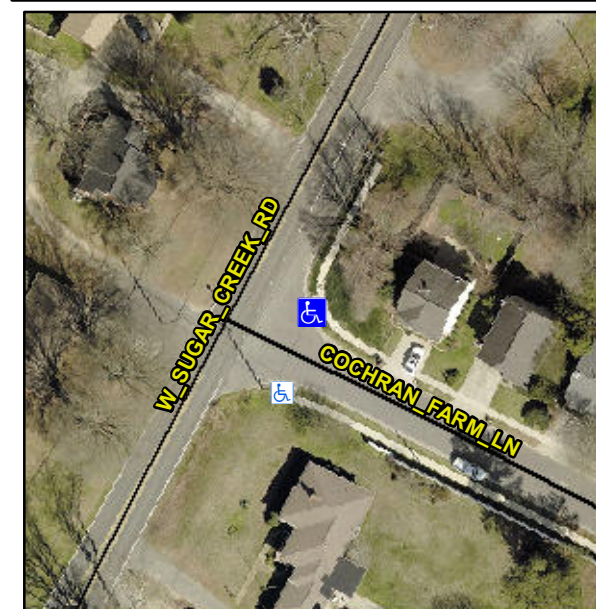
| ADA ID: 44CF43113DE9 | Ramp Type: Perp | Initial Pass/Fail: Fail | Overall Compliance: No |
| Severity Score: 12.5 | | | |

R304.2.2

| Compliance | Description | Data | Compliance | Description | Data |
|---|---|---|---|---|---|
| N/A | Ramp Length (in) | 48.0 | No | Ramp Slope (%) | 10.4 |
| Yes | Ramp Width (in) | 48.0 | Yes | Ramp XSlope (%) | 1.9 |

Possible Solutions:

Remove & Replace Entire Ramp.
