Access Compliance Report

Public Rights-of-Way

(Curb Ramps)

Intersection ID: 46698	Main Street: COFFEEBERRY_LN	Cross Street: TROTTERS_RIDGE_RD	Location: NE
ADA ID: 44DB4AE0AED5	Ramp Type: Perp	Initial Pass/Fail: Fail	Overall Compliance: No
Severity Score: 12.5			
Codes/Mitigation Info/Possible Solution		Field Measurements/Component Compliance

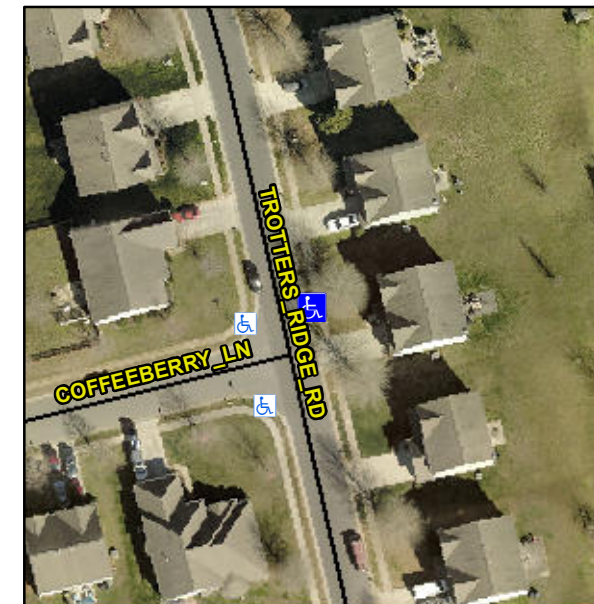
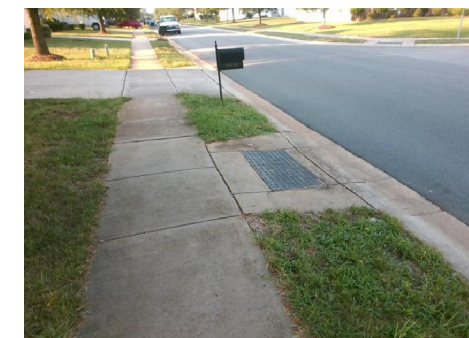
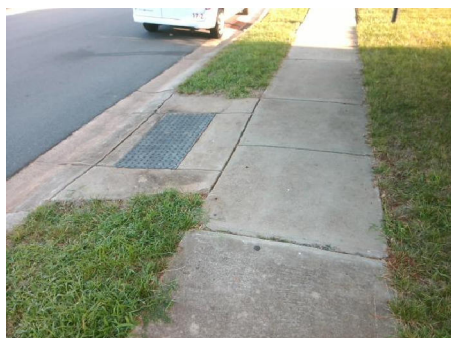
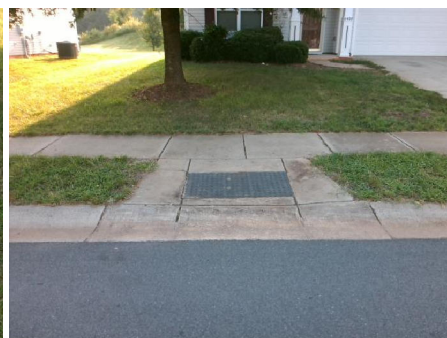
Not Found, R304.2.2

Compliance	Description	Data	Compliance	Description	Data
N/A	Ramp Length (in)	46.5	No	Ramp Slope (%)	10.7
Yes	Ramp Width (in)	48.0	Yes	Ramp XSlope (%)	1.9
N/A	Flare Type LT	N/A	N/A	Flare Type RT	N/A
N/A	Flare Slope LT (%)	N/A	N/A	Flare Slope RT (%)	N/A
N/A	Flare Traversable LT?	N/A	N/A	Flare Traversable RT?	N/A
N/A	Landing Length (in)	N/A	N/A	DWS Provided?	N/A
N/A	Landing Width (in)	N/A	N/A	DWS Contrast?	N/A
N/A	Landing Slope (%)	N/A	N/A	DWS Length (in)	N/A
N/A	Landing X Slope (%)	N/A	N/A	DWS Full Width?	N/A
N/A	Landing Curb? (Y/N)	N/A	N/A	DWS Offset (in)	N/A
N/A	Shared Landing?	N/A			
N/A	Gutter Ponding?	N/A	N/A	Gutter Slope (%)	N/A
N/A	Gutter Lip Ht (in)	N/A	N/A	Gutter X Slope (%)	N/A
N/A	Painted X Walk1?	No	N/A	Painted X Walk2?	N/A
	X Walk 1 Direction	To W		X Walk 2 Direction	N/A
N/A	X Walk 1 Width (in)	N/A	N/A	X Walk 2 Width (in)	N/A
	X Walk 1 Slope (%)	1.9		X Walk 2 Slope (%)	N/A
	X Walk 1 X Slope (%)	0.7		X Walk 2 X Slope (%)	N/A

N/A	Ramp inside XWalk1?	N/A	N/A	Ramp inside XWalk2?	N/A
	Road Slope (%)	N/A	N/A	Clear Space?	N/A
	Road X Slope (%)	N/A	N/A	Clear Space to XWalk (in)	N/A
N/A	Any Obstructions?	N/A	N/A	Storm Grate/Utility Hazard?	N/A
	Obstruction Type			Storm Grate/Utility Type	
		N/A			N/A
			Yes	Surface Condition? (G/P)	Good

Remove & Replace Entire Ramp.

Total Cost: \$ 1850.00
