# Access Compliance Report

## Public Rights-of-Way

### (Curb Ramps)

Intersection ID: N/A	Main Street: ELEANOR_RIGBY_RD	Cross Street: MAGGIE_MAY_LN	Location: SE
ADA ID: 44DB55ACB8D7	Ramp Type: Perp	Initial Pass/Fail: Fail	Overall Compliance: No
		Severity Score: 12.5

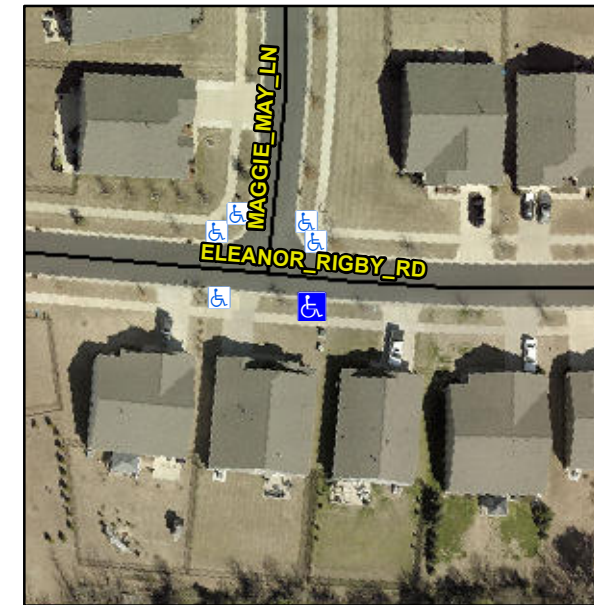
Compliance	Description	Data	Compliance	Description	Data
N/A	Ramp Length (in)	96.0	No	Ramp Slope (%)	8.6
Yes	Ramp Width (in)	51.0	Yes	Ramp XSlope (%)	0.5
N/A	Flare Type LT	N/A	N/A	Flare Type RT	N/A
N/A	Flare Slope LT (%)	N/A	N/A	Flare Slope RT (%)	N/A
N/A	Flare Traversable LT?	N/A	N/A	Flare Traversable RT?	N/A
N/A	Landing Length (in)	N/A	N/A	DWS Provided?	N/A
N/A	Landing Width (in)	N/A	N/A	DWS Contrast?	N/A
N/A	Landing Slope (%)	N/A	N/A	DWS Length (in)	N/A
N/A	Landing X Slope (%)	N/A	N/A	DWS Full Width?	N/A
N/A	Landing Curb? (Y/N)	N/A	N/A	DWS Offset (in)	N/A
N/A	Shared Landing?	N/A			
N/A	Gutter Ponding?	N/A	N/A	Gutter Slope (%)	N/A
N/A	Gutter Lip Ht (in)	N/A	N/A	Gutter X Slope (%)	N/A
N/A	Painted X Walk1?	No	N/A	Painted X Walk2?	N/A
	X Walk 1 Direction	To NE		X Walk 2 Direction	N/A
N/A	X Walk 1 Width (in)	N/A	N/A	X Walk 2 Width (in)	N/A
	X Walk 1 Slope (%)	3.3		X Walk 2 Slope (%)	N/A
	X Walk 1 X Slope (%)	0.7		X Walk 2 X Slope (%)	N/A

N/A	Ramp inside XWalk1?	N/A	N/A	Ramp inside XWalk2?	N/A
	Road Slope (%)	N/A	N/A	Clear Space?	N/A
	Road X Slope (%)	N/A	N/A	Clear Space to XWalk (in)	N/A
N/A	Any Obstructions?	N/A	N/A	Storm Grate/Utility Hazard?	N/A
	Obstruction Type			Storm Grate/Utility Type	
		N/A			N/A
			Yes	Surface Condition? (G/P)	Good

**Remove & Replace Entire Ramp.**

**R304.2.2**
