Access Compliance Report

Public Rights-of-Way

(Curb Ramps)

Intersection ID: N/A	Main Street: NATIONS_FORD_RD	Cross Street: N/A	Location: W
ADA ID: 44E0FD2BCD09	Ramp Type: Para	Initial Pass/Fail: Fail	Overall Compliance: No
Codes/Mitigation Info/Possible Solution		Field Measurements/Component Compliance

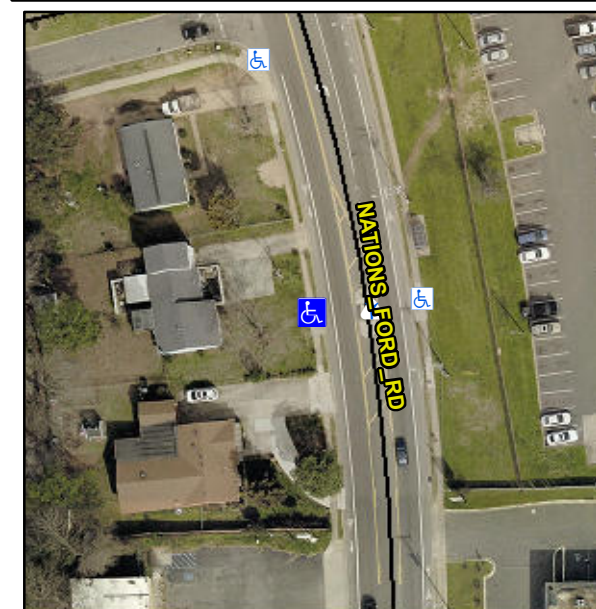
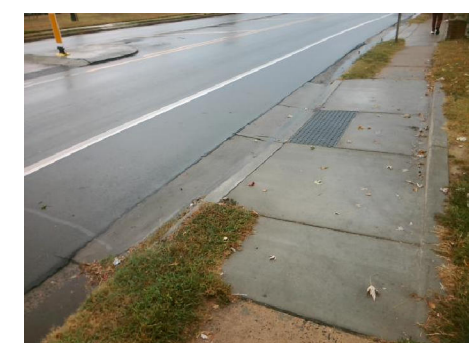
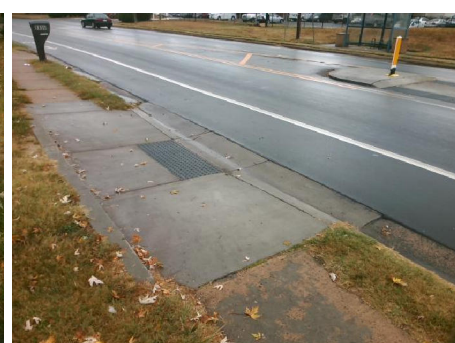
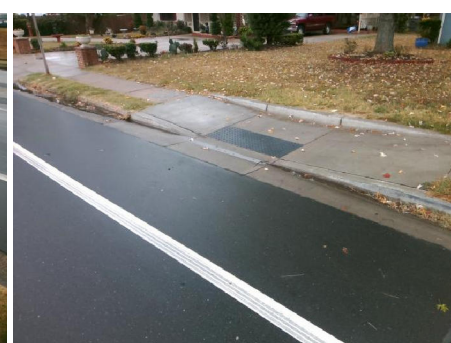
Compliance	Description	Data	Compliance	Description	Data
N/A	Ramp Length LT (in)	73.0	N/A	Ramp Length RT (in)	73.0
Yes	Ramp Width LT (in)	64.0	Yes	Ramp Width RT (in)	64.0
Yes	Ramp Slope LT (%)	7.3	No	Ramp Slope RT (%)	8.8
Yes	Ramp XSlope LT (%)	0.9	Yes	Ramp XSlope RT (%)	0.9
N/A	Landing Length (in)	N/A	N/A	DWS Provided?	N/A
N/A	Landing Width (in)	N/A	N/A	DWS Contrast?	N/A
N/A	Landing Slope (%)	N/A	N/A	DWS Length (in)	N/A
N/A	Landing X Slope (%)	N/A	N/A	DWS Full Width?	N/A
N/A	Landing Curb? (Y/N)	N/A	N/A	DWS Offset (in)	N/A
N/A	Shared Landing?	N/A			
N/A	Gutter Ponding?	N/A	N/A	Gutter Slope (%)	N/A
N/A	Gutter Lip Ht (in)	N/A	N/A	Gutter X Slope (%)	N/A
N/A	Painted X Walk1?	No	N/A	Painted X Walk2?	N/A
	X Walk 1 Direction	To E		X Walk 2 Direction	N/A
N/A	X Walk 1 Width (in)	N/A	N/A	X Walk 2 Width (in)	N/A
	X Walk 1 Slope (%)	6.2		X Walk 2 Slope (%)	N/A
	X Walk 1 X Slope (%)	0.4		X Walk 2 X Slope (%)	N/A
N/A	Ramp inside XWalk1?	N/A	N/A	Ramp inside XWalk2?	N/A

Road Slope (%)	N/A	N/A	Clear Space?	N/A
	Road X Slope (%)	N/A	N/A	Clear Space to XWalk (in)	N/A
N/A	Any Obstructions?	N/A	N/A	Storm Grate/Utility Hazard?	N/A
	Obstruction Type			Storm Grate/Utility Type	
		N/A			N/A
			Yes	Surface Condition? (G/P)	Good
			N/A	Curb Slope (%)	1.2

Remove & Replace Entire Ramp.

R304.3.2

\$ 1600.00
