Access Compliance Report

Public Rights-of-Way

(Curb Ramps)

Intersection ID: 46533	Main Street: GLEN_HOPE_LN	Cross Street: SUTTONVIEW_DR	Location:	N
ADA ID: 44E331126E44	Ramp Type: PerpDiag	Initial Pass/Fail: Fail	Overall Compliance: No	Severity Score: 10

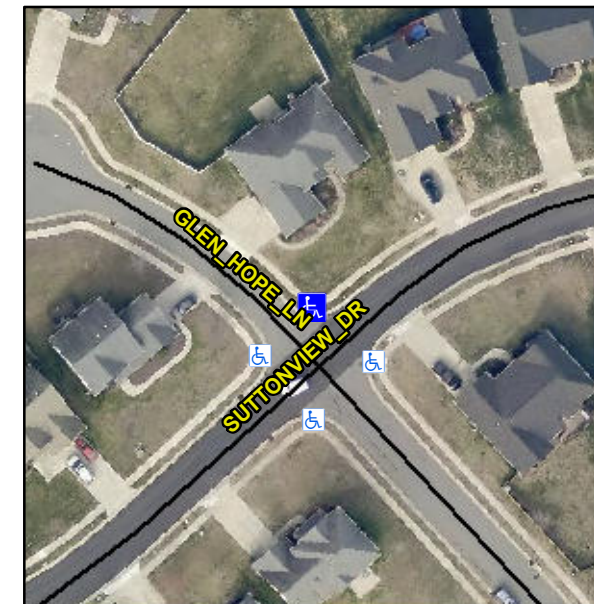
Not Found, R304.5.1, R304.5.3

Compliance	Description	Data	Compliance	Description	Data
N/A	Ramp Length (in)	48.5	Yes	Ramp Slope (%)	5.0
No	Ramp Width (in)	47.0	No	Ramp XSlope (%)	3.6
N/A	Flare Type LT	N/A	N/A	Flare Type RT	N/A
N/A	Flare Slope LT (%)	N/A	N/A	Flare Slope RT (%)	N/A
N/A	Flare Traversable LT?	N/A	N/A	Flare Traversable RT?	N/A
N/A	Landing Length (in)	N/A	N/A	DWS Provided?	N/A
N/A	Landing Width (in)	N/A	N/A	DWS Contrast?	N/A
N/A	Landing Slope (%)	N/A	N/A	DWS Length (in)	N/A
N/A	Landing X Slope (%)	N/A	N/A	DWS Full Width?	N/A
N/A	Landing Curb? (Y/N)	N/A	N/A	DWS Offset (in)	N/A
N/A	Shared Landing?	N/A			
N/A	Gutter Ponding?	N/A	N/A	Gutter Slope (%)	N/A
N/A	Gutter Lip Ht (in)	N/A	N/A	Gutter X Slope (%)	N/A
N/A	Painted X Walk1?	No	N/A	Painted X Walk2?	No
	X Walk 1 Direction	To SW		X Walk 2 Direction	To SE
N/A	X Walk 1 Width (in)	N/A	N/A	X Walk 2 Width (in)	N/A
	X Walk 1 Slope (%)	5.8		X Walk 2 Slope (%)	3.5
	X Walk 1 X Slope (%)	2.1		X Walk 2 X Slope (%)	7.1

N/A	Ramp inside XWalk1?	N/A	N/A	Ramp inside XWalk2?	N/A
	Road Slope (%)	5.1	N/A	Clear Space?	N/A
	Road X Slope (%)	4.2	N/A	Clear Space to XWalk (in)	N/A
N/A	Any Obstructions?	N/A	N/A	Storm Grate/Utility Hazard?	N/A
	Obstruction Type			Storm Grate/Utility Type	
		N/A			N/A
			Yes	Surface Condition? (G/P)	Good

Remove & Replace Curb Ramp With Two New Directional Ramps or Equivalent.
