Access Compliance Report

Public Rights-of-Way

(Curb Ramps)

Intersection ID: 16048	Main Street: OXFORD_PL	Cross Street: PROVIDENCE_RD	Location: SW
ADA ID: 44E349AA1071	Ramp Type: Perp	Initial Pass/Fail: Fail	Overall Compliance: No
Severity Score: 35			
Codes/Mitigation Info/Possible Solution		Field Measurements/Component Compliance

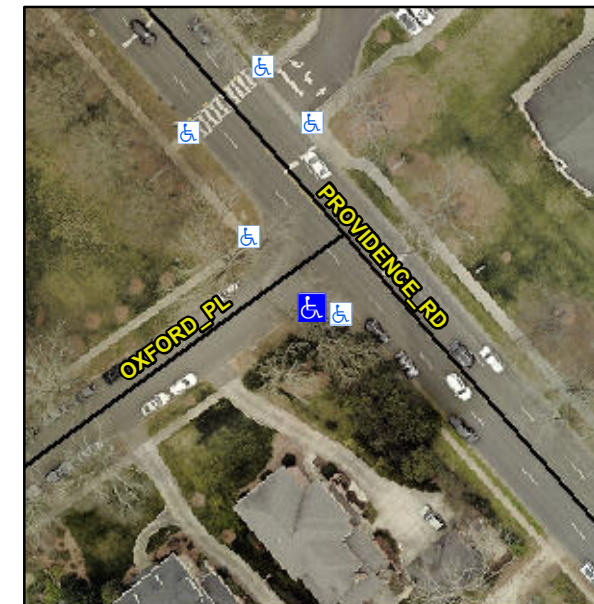
Not Found, R304.5.1, R304.2.2, R304.5.3

Compliance	Description	Data	Compliance	Description	Data
N/A	Ramp Length (in)	40.0	No	Ramp Slope (%)	14.9
No	Ramp Width (in)	47.0	No	Ramp XSlope (%)	2.7
N/A	Flare Type LT	N/A	N/A	Flare Type RT	N/A
N/A	Flare Slope LT (%)	N/A	N/A	Flare Slope RT (%)	N/A
N/A	Flare Traversable LT?	N/A	N/A	Flare Traversable RT?	N/A
N/A	Landing Length (in)	N/A	N/A	DWS Provided?	N/A
N/A	Landing Width (in)	N/A	N/A	DWS Contrast?	N/A
N/A	Landing Slope (%)	N/A	N/A	DWS Length (in)	N/A
N/A	Landing X Slope (%)	N/A	N/A	DWS Full Width?	N/A
N/A	Landing Curb? (Y/N)	N/A	N/A	DWS Offset (in)	N/A
N/A	Shared Landing?	N/A			
N/A	Gutter Ponding?	N/A	N/A	Gutter Slope (%)	N/A
N/A	Gutter Lip Ht (in)	N/A	N/A	Gutter X Slope (%)	N/A
N/A	Painted X Walk1?	No	N/A	Painted X Walk2?	N/A
	X Walk 1 Direction	To NW		X Walk 2 Direction	N/A
N/A	X Walk 1 Width (in)	N/A	N/A	X Walk 2 Width (in)	N/A
	X Walk 1 Slope (%)	2.8		X Walk 2 Slope (%)	N/A
	X Walk 1 X Slope (%)	2.3		X Walk 2 X Slope (%)	N/A

N/A	Ramp inside XWalk1?	N/A	N/A	Ramp inside XWalk2?	N/A
	Road Slope (%)	N/A	N/A	Clear Space?	N/A
	Road X Slope (%)	N/A	N/A	Clear Space to XWalk (in)	N/A
N/A	Any Obstructions?	N/A	N/A	Storm Grate/Utility Hazard?	N/A
	Obstruction Type			Storm Grate/Utility Type	
		N/A			N/A
			Yes	Surface Condition? (G/P)	Good

Possible Solutions:

Remove & Replace Entire Ramp.
