# Access Compliance Report

## Public Rights-of-Way

### (Curb Ramps)

Intersection ID: 27040	Main Street: PIPER_GLEN_DR	Cross Street: REA_RD	Location: SW
ADA ID: 44F1E026CE1C	Ramp Type: Directional1	Initial Pass/Fail: Fail	Overall Compliance: No
Codes/Mitigation Info/Possible Solution		Field Measurements/Component Compliance	
Severity Score: 13.75

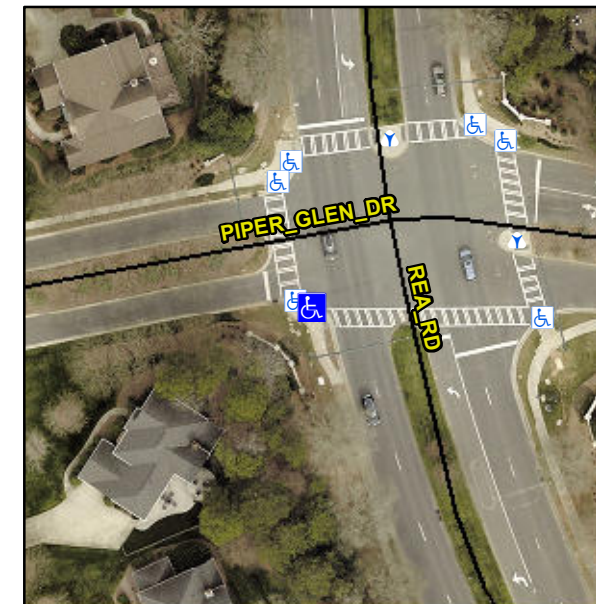
**R304.2.2, R304.5.3**

Compliance	Description	Data	Compliance	Description	Data
N/A	Ramp Length (in)	45.0	N/A	Grade Break?	N/A
Yes	Ramp Width (in)	72.0	N/A	Grade Break Slope (%)	0.0
No	Ramp Slope (%)	8.9	N/A	Grade Break XSlope (%)	0.0
No	Ramp XSlope (%)	3.0			
N/A	Flare Type LT	N/A	N/A	Flare Type RT	N/A
N/A	Flare Slope LT (%)	N/A	N/A	Flare Slope RT (%)	0.0
N/A	Flare Traversable LT?	N/A	N/A	Flare Traversable RT?	N/A
N/A	Landing Length (in)	0.0	N/A	DWS Provided?	N/A
N/A	Landing Width (in)	0.0	N/A	DWS Contrast?	N/A
N/A	Landing Slope (%)	0.0	N/A	DWS Length (in)	N/A
N/A	Landing X Slope (%)	0.0	N/A	DWS Full Width?	N/A
N/A	Landing Curb? (Y/N)	N/A	N/A	DWS Offset LT (in)	N/A
N/A	Shared Landing?	N/A	N/A	DWS Offset RT (in)	N/A
N/A	Gutter Ponding?	0.0	N/A	Gutter Slope (%)	N/A
N/A	Gutter Lip Ht (in)	0.0	N/A	Gutter X Slope (%)	N/A
N/A	Painted X Walk1?	Yes		Road Slope (%)	0.5
	X Walk 1 Direction	To NE		Road X Slope (%)	1.7
	X Walk 1 Width (in)	124.0		Clear Space?	N/A

X Walk 1 Slope (%)	0.5	N/A	Clear Space to XWalk (in)	N/A
	X Walk 1 X Slope (%)	1.7	N/A	Storm Grate/Utility Hazard?	N/A
N/A	Ramp inside XWalk1?	Yes		Storm Grate/Utility Type	
N/A	Any Obstructions?	N/A			N/A
	Obstruction Type		Yes	Surface Condition? (G/P)	Good
			N/A	Curb Slope (%)	6.0

**Remove & Replace Entire Ramp.**

Total Cost: \$ 1600.00
