Access Compliance Report

Public Rights-of-Way (Curb Ramps)

Intersection ID: 30637	Main Street: NORTHSPRINGS_DR	Cross Street: PROVIDENCE_RD_WEST	Location: SE
ADA ID: 44FF7938AB35	Ramp Type: PerpDiag	Initial Pass/Fail: Fail	Overall Compliance: No
Codes/Mitigation Info/Possible Solution		Field Measurements/Component Compliance

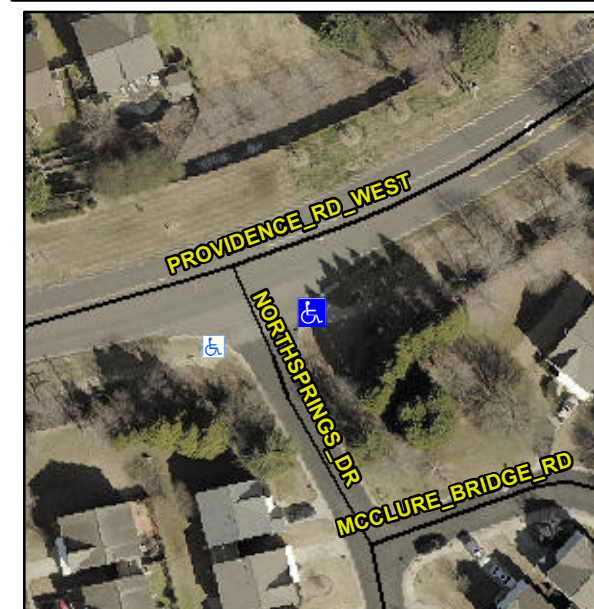
Not Found, R304.5.1, R304.2.2

Compliance	Description	Data	Compliance	Description	Data
N/A	Ramp Length (in)	59.0	No	Ramp Slope (%)	8.6
No	Ramp Width (in)	46.0	Yes	Ramp XSlope (%)	0.6
N/A	Flare Type LT	N/A	N/A	Flare Type RT	N/A
N/A	Flare Slope LT (%)	N/A	N/A	Flare Slope RT (%)	N/A
N/A	Flare Traversable LT?	N/A	N/A	Flare Traversable RT?	N/A
N/A	Landing Length (in)	N/A	N/A	DWS Provided?	N/A
N/A	Landing Width (in)	N/A	N/A	DWS Contrast?	N/A
N/A	Landing Slope (%)	N/A	N/A	DWS Length (in)	N/A
N/A	Landing X Slope (%)	N/A	N/A	DWS Full Width?	N/A
N/A	Landing Curb? (Y/N)	N/A	N/A	DWS Offset (in)	N/A
N/A	Shared Landing?	N/A			
N/A	Gutter Ponding?	N/A	N/A	Gutter Slope (%)	N/A
N/A	Gutter Lip Ht (in)	N/A	N/A	Gutter X Slope (%)	N/A
N/A	Painted X Walk1?	No	N/A	Painted X Walk2?	No
	X Walk 1 Direction	To N		X Walk 2 Direction	To W
N/A	X Walk 1 Width (in)	N/A	N/A	X Walk 2 Width (in)	N/A
	X Walk 1 Slope (%)	7.5		X Walk 2 Slope (%)	2.2
	X Walk 1 X Slope (%)	2.2		X Walk 2 X Slope (%)	4.3

N/A	Ramp inside XWalk1?	N/A	N/A	Ramp inside XWalk2?	N/A
	Road Slope (%)	3.0	N/A	Clear Space?	N/A
	Road X Slope (%)	6.3	N/A	Clear Space to XWalk (in)	N/A
N/A	Any Obstructions?	N/A	N/A	Storm Grate/Utility Hazard?	N/A
	Obstruction Type			Storm Grate/Utility Type	
		N/A			N/A
			Yes	Surface Condition? (G/P)	Good

Remove & Replace Curb Ramp With Two New Directional Ramps or Equivalent.
