# Access Compliance Report

## Public Rights-of-Way

| Intersection ID: 28035 | Main Street: MITCHELL_GLEN_DR | Cross Street: KILPATRICK_LN | Location: SE |
| ADA ID: 450403B66879 | Ramp Type: PerpDiag | Initial Pass/Fail: Pass | Overall Compliance: No |

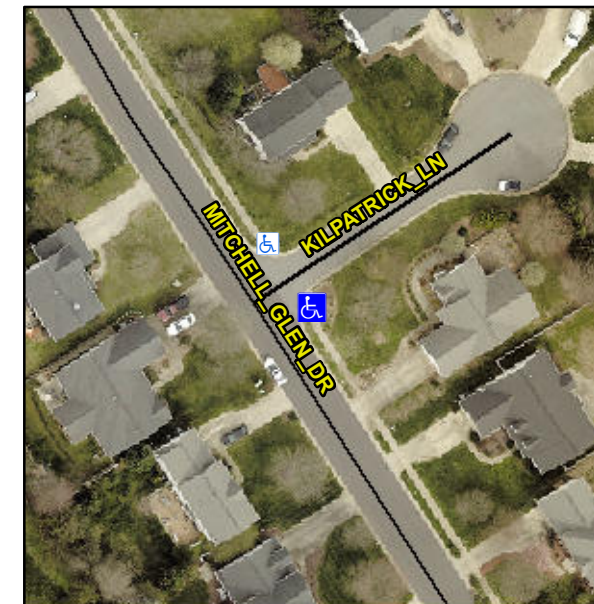
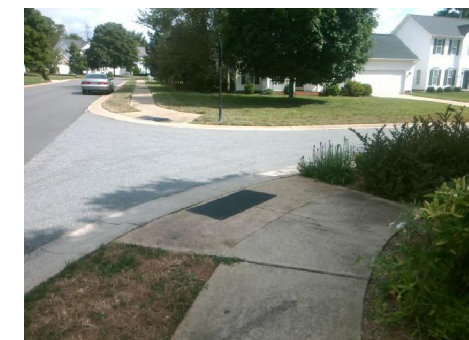
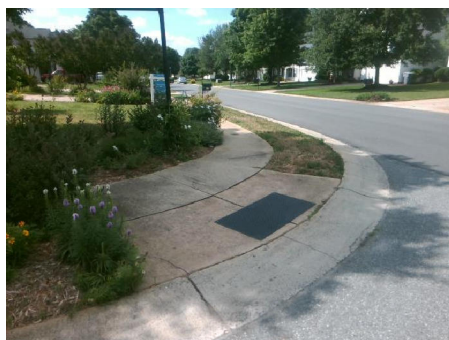
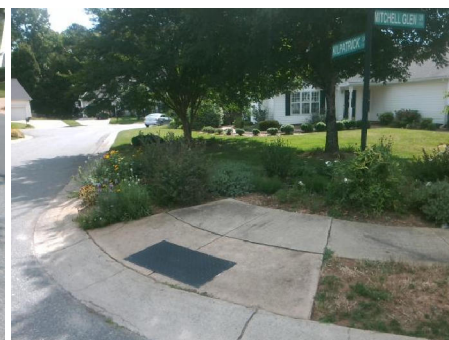
**R304.2.1, R304.2.2-Perp, R304.3.2-Para, R304.5.3, R305.1.4, R305.2, R304.5.4**

| Compliance | Description | Data | Compliance | Description | Data |
|---|---|---|---|---|---|
| No | Landing Length (in) | N/A | Yes | DWS Provided? | Yes |
| No | Landing X Slope (%) | N/A | No | DWS Full Width? | No |
| Yes | Gutter Ponding? | No | No | Gutter Slope (%) | 5.1 |

**Remove & Replace Curb Ramp With Two New Directional Ramps or Equivalent. Remove & Replace Gutter.**
