# Access Compliance Report

## Public Rights-of-Way

### (Curb Ramps)

| Intersection ID: 48569 | Main Street: RED_SQUIRREL_TL | Cross Street: SALAMANDER_RUN_LN | Location: SW |

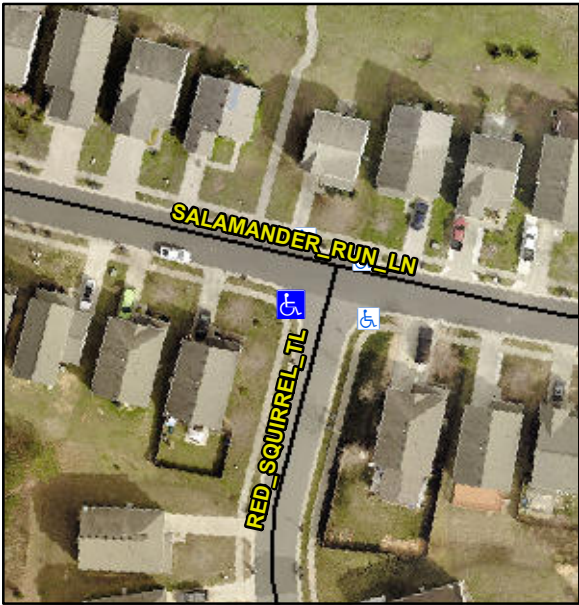
| Codes/Mitigation Info/Possible Solution | | | Field Measurements/Component Compliance | | | | | |
|---|---|---|---|---|---|---|---|---|
| | | | Yes | Ramp Width (in) | 48.0 | No | Ramp XSlope (%) | 3.8 |
| | | | No | Landing Length (in) | 47.5 | Yes | DWS Provided? | Yes |
| | | | No | Landing X Slope (%) | 5.8 | Yes | DWS Full Width? | Yes |
| PROW/ADA: | | Not Found, R304.5.3, R304.2.1, R305.2, R302.7, R302.7.2, R304.5.4 | N/A | Shared Landing? | No | | | |
| | | | No | Gutter Ponding? | Yes | No | Gutter Slope (%) | 12.5 |
| | | | No | Gutter Lip Ht (in) | 0.5 | No | Gutter X Slope (%) | 3.0 |

| Codes/Mitigation Info/Possible Solution | | | Field Measurements/Component Compliance | | | | | |
|---|---|---|---|---|---|---|---|---|
| | Remove & Replace Curb Ramp With Two New Directional Ramps or Equivalent. Remove & Replace Gutter. | | N/A | Ramp Length (in) | 46.0 | Yes | Ramp Slope (%) | 7.8 |

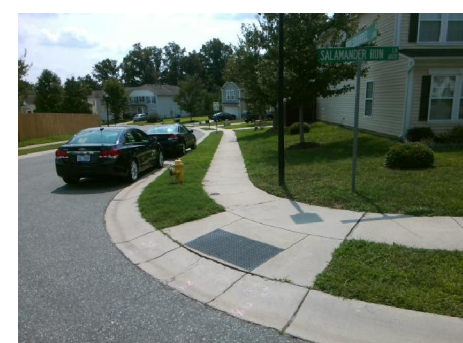
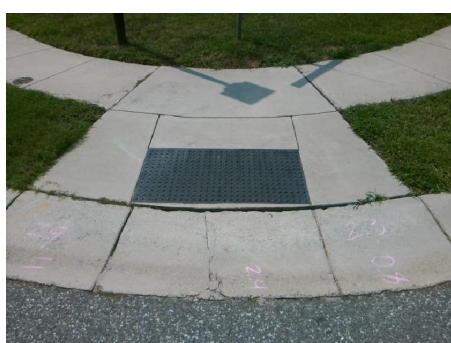
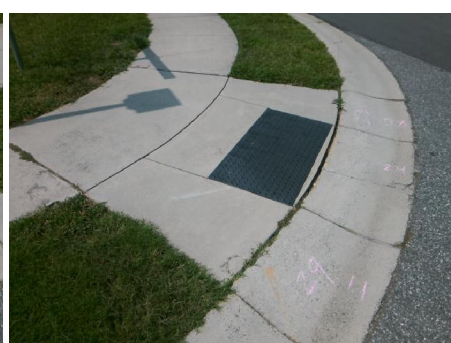
| ADA ID: 45079122C981 | Ramp Type: PerpDiag | Initial Pass/Fail: Pass | Overall Compliance: No |
| | | | Severity Score: 12.75 |
