# Access Compliance Report

## Public Rights-of-Way

### (Curb Ramps)

Intersection ID: 11879	Main Street: AIRLIE_ST	Cross Street: ELLEN_AV	Location: SW
ADA ID: 45096079461C	Ramp Type: Perp	Initial Pass/Fail: Fail	Overall Compliance: No
Severity Score: 21.25			
Codes/Mitigation Info/Possible Solution		Field Measurements/Component Compliance

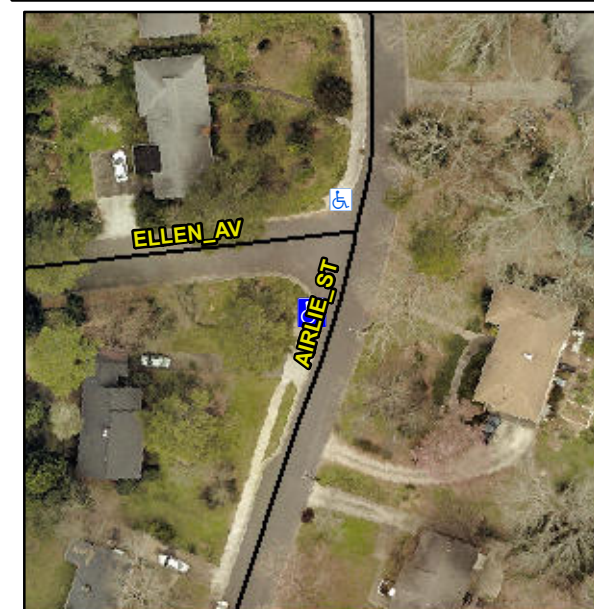
**Not Found, R304.5.1, R304.5.3**

Compliance	Description	Data	Compliance	Description	Data
N/A	Ramp Length (in)	73.0	Yes	Ramp Slope (%)	5.1
No	Ramp Width (in)	43.0	No	Ramp XSlope (%)	5.4
N/A	Flare Type LT	N/A	N/A	Flare Type RT	N/A
N/A	Flare Slope LT (%)	N/A	N/A	Flare Slope RT (%)	N/A
N/A	Flare Traversable LT?	N/A	N/A	Flare Traversable RT?	N/A
N/A	Landing Length (in)	N/A	N/A	DWS Provided?	N/A
N/A	Landing Width (in)	N/A	N/A	DWS Contrast?	N/A
N/A	Landing Slope (%)	N/A	N/A	DWS Length (in)	N/A
N/A	Landing X Slope (%)	N/A	N/A	DWS Full Width?	N/A
N/A	Landing Curb? (Y/N)	N/A	N/A	DWS Offset (in)	N/A
N/A	Shared Landing?	N/A			
N/A	Gutter Ponding?	N/A	N/A	Gutter Slope (%)	N/A
N/A	Gutter Lip Ht (in)	N/A	N/A	Gutter X Slope (%)	N/A
N/A	Painted X Walk1?	No	N/A	Painted X Walk2?	N/A
	X Walk 1 Direction	To N		X Walk 2 Direction	N/A
N/A	X Walk 1 Width (in)	N/A	N/A	X Walk 2 Width (in)	N/A
	X Walk 1 Slope (%)	6.4		X Walk 2 Slope (%)	N/A
	X Walk 1 X Slope (%)	0.2		X Walk 2 X Slope (%)	N/A

N/A	Ramp inside XWalk1?	N/A	N/A	Ramp inside XWalk2?	N/A
	Road Slope (%)	N/A	N/A	Clear Space?	N/A
	Road X Slope (%)	N/A	N/A	Clear Space to XWalk (in)	N/A
N/A	Any Obstructions?	N/A	N/A	Storm Grate/Utility Hazard?	N/A
	Obstruction Type			Storm Grate/Utility Type	
		N/A			N/A
			Yes	Surface Condition? (G/P)	Good

Possible Solutions:

**Remove & Replace Entire Ramp.**

Total Cost: \$ 1850.00
