# Access Compliance Report

## Public Rights-of-Way

### (Curb Ramps)

Intersection ID: 31212	Main Street: GRANTHAM_LN	Cross Street: WESTBURY_GLEN_CT	Location: NW
ADA ID: 4511F2A3161D	Ramp Type: Perp	Initial Pass/Fail: Fail	Overall Compliance: No
Severity Score: 25			
Codes/Mitigation Info/Possible Solution		Field Measurements/Component Compliance

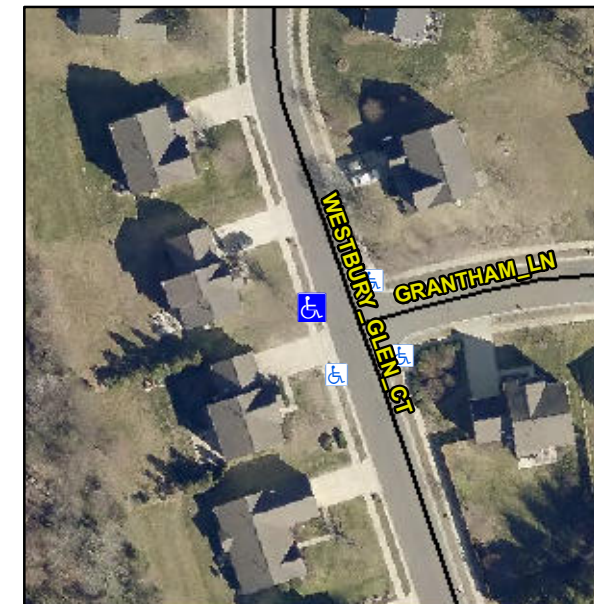
**Not Found, R304.2.2**

Compliance	Description	Data	Compliance	Description	Data
N/A	Ramp Length (in)	48.0	No	Ramp Slope (%)	15.7
Yes	Ramp Width (in)	49.0	Yes	Ramp XSlope (%)	0.1
N/A	Flare Type LT	N/A	N/A	Flare Type RT	N/A
N/A	Flare Slope LT (%)	N/A	N/A	Flare Slope RT (%)	N/A
N/A	Flare Traversable LT?	N/A	N/A	Flare Traversable RT?	N/A
N/A	Landing Length (in)	N/A	N/A	DWS Provided?	N/A
N/A	Landing Width (in)	N/A	N/A	DWS Contrast?	N/A
N/A	Landing Slope (%)	N/A	N/A	DWS Length (in)	N/A
N/A	Landing X Slope (%)	N/A	N/A	DWS Full Width?	N/A
N/A	Landing Curb? (Y/N)	N/A	N/A	DWS Offset (in)	N/A
N/A	Shared Landing?	N/A			
N/A	Gutter Ponding?	N/A	N/A	Gutter Slope (%)	N/A
N/A	Gutter Lip Ht (in)	N/A	N/A	Gutter X Slope (%)	N/A
N/A	Painted X Walk1?	No	N/A	Painted X Walk2?	N/A
	X Walk 1 Direction	To E		X Walk 2 Direction	N/A
N/A	X Walk 1 Width (in)	N/A	N/A	X Walk 2 Width (in)	N/A
	X Walk 1 Slope (%)	5.7		X Walk 2 Slope (%)	N/A
	X Walk 1 X Slope (%)	1.6		X Walk 2 X Slope (%)	N/A

**Remove & Replace Entire Ramp.**

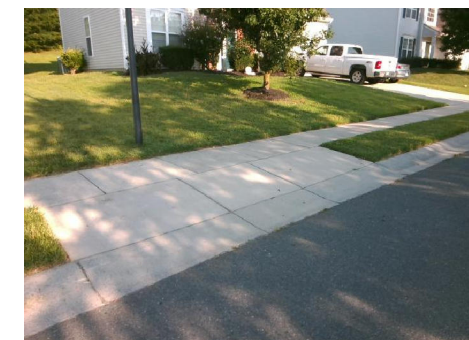
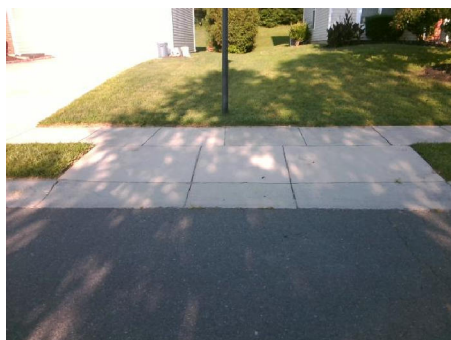
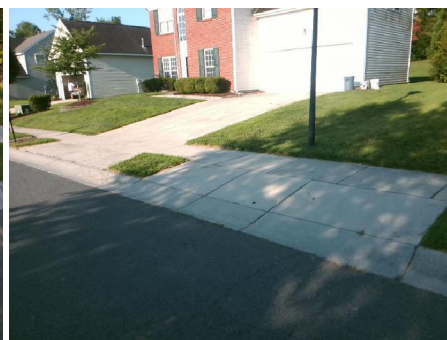
N/A	Ramp inside XWalk1?	N/A	N/A	Ramp inside XWalk2?	N/A
	Road Slope (%)	N/A	N/A	Clear Space?	N/A
	Road X Slope (%)	N/A	N/A	Clear Space to XWalk (in)	N/A
N/A	Any Obstructions?	N/A	N/A	Storm Grate/Utility Hazard?	N/A
	Obstruction Type			Storm Grate/Utility Type	
		N/A			N/A
			Yes	Surface Condition? (G/P)	Good
