# Access Compliance Report

## Public Rights-of-Way

### (Curb Ramps)

Intersection ID: 52452	Main Street: PAT_GARRETT_ST	Cross Street: BENDING_BIRCH_PL	Location: SE
ADA ID: 451435787ACF	Ramp Type: Directional1	Initial Pass/Fail: Fail	Overall Compliance: No
Severity Score: 37.5			
Codes/Mitigation Info/Possible Solution		Field Measurements/Component Compliance

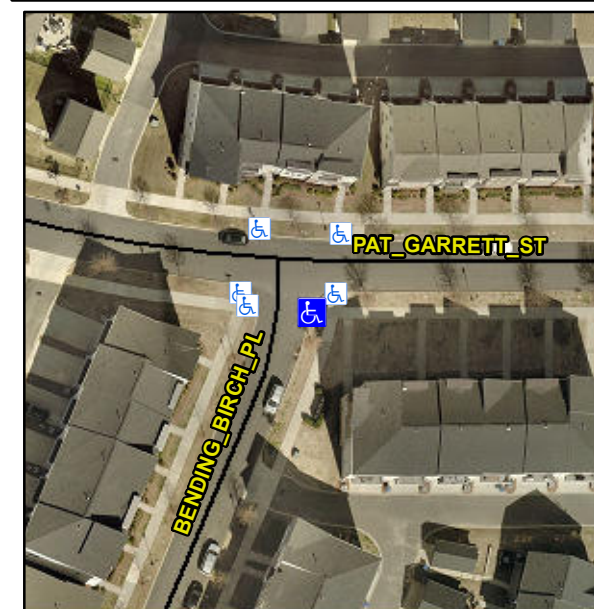
Compliance	Description	Data	Compliance	Description	Data
N/A	Ramp Length (in)	93.0	N/A	Grade Break?	N/A
Yes	Ramp Width (in)	66.0	N/A	Grade Break Slope (%)	0.0
No	Ramp Slope (%)	12.9	N/A	Grade Break XSlope (%)	0.0
No	Ramp XSlope (%)	6.9			
N/A	Flare Type LT	N/A	N/A	Flare Type RT	N/A
N/A	Flare Slope LT (%)	N/A	N/A	Flare Slope RT (%)	0.0
N/A	Flare Traversable LT?	N/A	N/A	Flare Traversable RT?	N/A
N/A	Landing Length (in)	0.0	N/A	DWS Provided?	N/A
N/A	Landing Width (in)	0.0	N/A	DWS Contrast?	N/A
N/A	Landing Slope (%)	0.0	N/A	DWS Length (in)	N/A
N/A	Landing X Slope (%)	0.0	N/A	DWS Full Width?	N/A
N/A	Landing Curb? (Y/N)	N/A	N/A	DWS Offset LT (in)	N/A
N/A	Shared Landing?	N/A	N/A	DWS Offset RT (in)	N/A
N/A	Gutter Ponding?	0.0	N/A	Gutter Slope (%)	N/A
N/A	Gutter Lip Ht (in)	0.0	N/A	Gutter X Slope (%)	N/A
N/A	Painted X Walk1?	No		Road Slope (%)	1.0
	X Walk 1 Direction	To W		Road X Slope (%)	2.6
	X Walk 1 Width (in)	N/A		Clear Space?	N/A

X Walk 1 Slope (%)	1.0	N/A	Clear Space to XWalk (in)	N/A
	X Walk 1 X Slope (%)	2.6	N/A	Storm Grate/Utility Hazard?	N/A
N/A	Ramp inside XWalk1?	N/A		Storm Grate/Utility Type	
N/A	Any Obstructions?	N/A			N/A
	Obstruction Type		Yes	Surface Condition? (G/P)	Good
			N/A	Curb Slope (%)	0.7

**Remove & Replace Entire Ramp.**

**R304.2.2, R304.5.3**
