# Access Compliance Report

## Public Rights-of-Way

Intersection ID: 13899		Main Street: HAWKINS_ST		Cross Street: WEST_BV		Location: NE			
ADA ID: 451692FC60E9		Ramp Type: PerpDiag		Initial Pass/Fail: Fail		Overall Compliance: No		Severity Score: 22.5	
Codes/Mitigation Info/Possible Solution				Field Measurements/Component Compliance

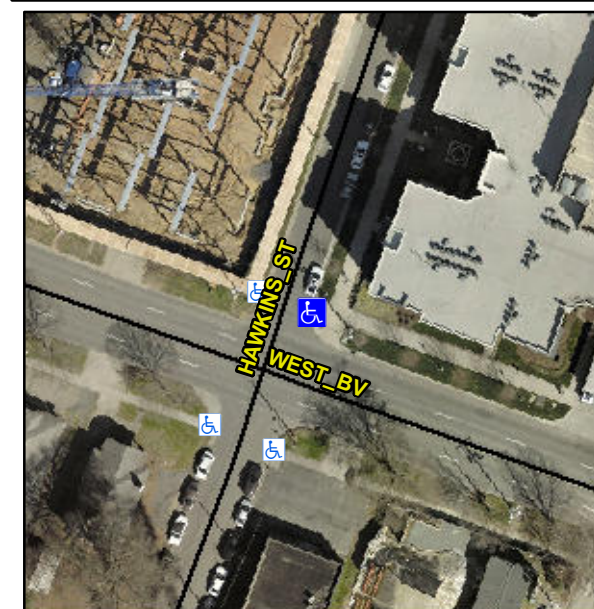
Compliance	Description	Data	Compliance	Description	Data
N/A	Ramp Length (in)	122.0	No	Ramp Slope (%)	9.8
No	Ramp Width (in)	44.5	No	Ramp XSlope (%)	2.1
N/A	Flare Type LT	N/A	N/A	Flare Type RT	N/A
N/A	Flare Slope LT (%)	N/A	N/A	Flare Slope RT (%)	N/A
N/A	Flare Traversable LT?	N/A	N/A	Flare Traversable RT?	N/A
N/A	Landing Length (in)	N/A	N/A	DWS Provided?	N/A
N/A	Landing Width (in)	N/A	N/A	DWS Contrast?	N/A
N/A	Landing Slope (%)	N/A	N/A	DWS Length (in)	N/A
N/A	Landing X Slope (%)	N/A	N/A	DWS Full Width?	N/A
N/A	Landing Curb? (Y/N)	N/A	N/A	DWS Offset (in)	N/A
N/A	Shared Landing?	N/A			
N/A	Gutter Ponding?	N/A	N/A	Gutter Slope (%)	N/A
N/A	Gutter Lip Ht (in)	N/A	N/A	Gutter X Slope (%)	N/A
N/A	Painted X Walk1?	No	N/A	Painted X Walk2?	No
	X Walk 1 Direction	To W		X Walk 2 Direction	To S
N/A	X Walk 1 Width (in)	N/A	N/A	X Walk 2 Width (in)	N/A
	X Walk 1 Slope (%)	2.8		X Walk 2 Slope (%)	4.5
	X Walk 1 X Slope (%)	1.1		X Walk 2 X Slope (%)	0.8

N/A	Ramp inside XWalk1?	N/A	N/A	Ramp inside XWalk2?	N/A
	Road Slope (%)	1.7	N/A	Clear Space?	N/A
	Road X Slope (%)	1.5	N/A	Clear Space to XWalk (in)	N/A
N/A	Any Obstructions?	N/A	N/A	Storm Grate/Utility Hazard?	N/A
	Obstruction Type			Storm Grate/Utility Type	
		N/A			N/A
		Yes		Surface Condition? (G/P)	Good

**Remove & Replace Curb Ramp With Two New Directional Ramps or Equivalent.**

**R304.5.1, R304.2.2, R304.5.3**
