Access Compliance Report Public Rights-of-Way (Curb Ramps)

Intersection ID: 19528 Main Street: SOUTH BV **Cross Street: EMERYWOOD DR** Location: NE **Overall Compliance: No** ADA ID: 45239AF611FE Ramp Type: Perp Initial Pass/Fail: Fail Severity Score: 13.75

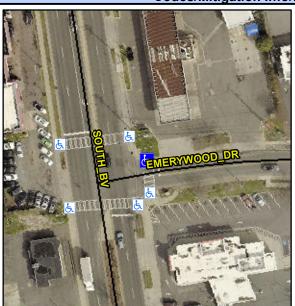
D. III O. II		Tield incusarements/component compilation				
Possible Solutions:		liance Description	Data		liance Description	Data
Remove & Replace Entire Ramp.	N/A	Ramp Length (in)	70.0	No	Ramp Slope (%)	8.8
	Yes	Ramp Width (in)	48.0	No	Ramp XSlope (%)	2.3
	N/A	Flare Type LT	N/A	N/A	Flare Type RT	N/A
	N/A	Flare Slope LT (%)	N/A	N/A	Flare Slope RT (%)	N/A
	N/A	Flare Traversable LT?	N/A	N/A	Flare Traversable RT?	N/A
	N/A	Landing Length (in)	N/A	N/A	DWS Provided?	N/A
Surveyor Notes:	N/A	Landing Width (in)	N/A	N/A	DWS Contrast?	N/A
N/A	N/A	Landing Slope (%)	N/A	N/A	DWS Length (in)	N/A
	N/A	Landing X Slope (%)	N/A	N/A	DWS Full Width?	N/A
	N/A	Landing Curb? (Y/N)	N/A	N/A	DWS Offset (in)	N/A
	N/A	Shared Landing?	N/A			
PROW/ADA:	N/A	Gutter Ponding?	N/A	N/A	Gutter Slope (%)	N/A
Not Found, R304.2.2, R304.5.3	N/A	Gutter Lip Ht (in)	N/A	N/A	Gutter X Slope (%)	N/A
,	N/A	Painted X Walk1?	Yes	N/A	Painted X Walk2?	N/A

X Walk 1 Direction	To S		X Walk 2 Direction	N/A
	N/A	X Walk 1 Width (in)	112.0	N/A	X Walk 2 Width (in)	N/A
		X Walk 1 Slope (%)	0.9		X Walk 2 Slope (%)	N/A
		X Walk 1 X Slope (%)	1.9		X Walk 2 X Slope (%)	N/A
	N/A	Ramp inside XWalk1?	Yes	N/A	Ramp inside XWalk2?	N/A
		Road Slope (%)	N/A	N/A	Clear Space?	N/A
		Road X Slope (%)	N/A	N/A	Clear Space to XWalk (in)	N/A
	N/A	Any Obstructions?	N/A	N/A	Storm Grate/Utility Hazard?	N/A
Total Cost: \$ 1850.00		Obstruction Type			Storm Grate/Utility Type	
			N/A			N/A
				Yes	Surface Condition? (G/P)	Good

Codes/Mitigation Info/Possible Solution
