## Access Compliance Report Public Rights-of-Way (Curb Ramps)

Intersection ID: 27788Main Street: PROVIDENCE\_RDCross Street: PROVIDENCE\_COUNTRY\_CLUB\_DRLocation:SWADA ID: 4526E0C7DA02Ramp Type: ParaInitial Pass/Fail: FailOverall Compliance: NoSeverity Score:10

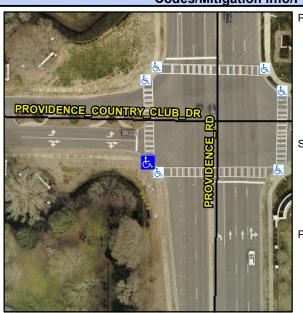
RT RP < 5%

Field Measurements/Component Compliance					
Compliance Description		Data	Compliance Description		Data
N/A	Ramp Length LT (in)	53.0	N/A	Ramp Length RT (in)	66.0
Yes	Ramp Width LT (in)	48.0	No	Ramp Width RT (in)	47.0
Yes	Ramp Slope LT (%)	7.2	Yes	Ramp Slope RT (%)	4.9
No	Ramp XSlope LT (%)	2.9	No	Ramp XSlope RT (%)	3.0
N/A	Landing Length (in)	N/A	N/A	DWS Provided?	N/A
N/A	Landing Width (in)	N/A	N/A	DWS Contrast?	N/A
N/A	Landing Slope (%)	N/A	N/A	DWS Length (in)	N/A
N/A	Landing X Slope (%)	N/A	N/A	DWS Full Width?	N/A
N/A	Landing Curb? (Y/N)	N/A	N/A	DWS Offset (in)	N/A
N/A	Shared Landing?	N/A			
N/A	Gutter Ponding?	N/A	N/A	Gutter Slope (%)	N/A
N/A	Gutter Lip Ht (in)	N/A	N/A	Gutter X Slope (%)	N/A
N/A	Painted X Walk1?	Yes	N/A	Painted X Walk2?	N/A
	X Walk 1 Direction	To N		X Walk 2 Direction	N/A
N/A	X Walk 1 Width (in)	99.0	N/A	X Walk 2 Width (in)	N/A
	X Walk 1 Slope (%)	3.8		X Walk 2 Slope (%)	N/A
	X Walk 1 X Slope (%)	3.2		X Walk 2 X Slope (%)	N/A

N/A	Ramp inside XWalk1?	Yes	N/A	Ramp inside XWalk2?	N/A
	Road Slope (%)	N/A	N/A	Clear Space?	N/A
	Road X Slope (%)	N/A	N/A	Clear Space to XWalk (in)	N/A
N/A	Any Obstructions?	N/A	N/A	Storm Grate/Utility Hazard?	N/A
	Obstruction Type			Storm Grate/Utility Type	
	,,	N/A		, ,,	N/A
			Yes	Surface Condition? (G/P)	Good
			N/A	Curb Slope (%)	7.3

Remove & Replace Entire Ramp.
