# Access Compliance Report

## Public Rights-of-Way

| Intersection ID: 22786 | Main Street: INDIAN_HILLS_LN | Cross Street: PECAN_MEADOW_CT | Location: W |
| ADA ID: 452E2F92966D | Ramp Type: Directional1 | Initial Pass/Fail: Fail | Overall Compliance: No |

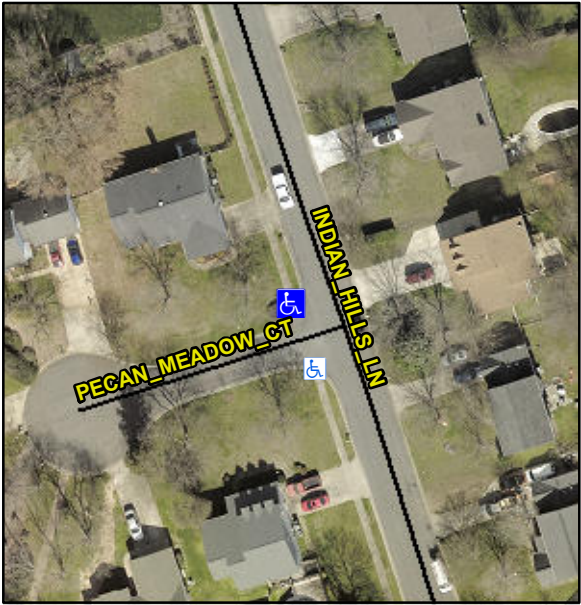
| | | | Severity Score: 21.25 |

| Codes/Mitigation Info/Possible Solution | | | Field Measurements/Component Compliance | | | |
|---|---|--|---|---|---|--|
| | | | <b>No</b> | Ramp Width (in) | <b>39.0</b> | |
| | | | <b>No</b> | Ramp Slope (%) | <b>8.4</b> | |
| <p>PROW/ADA:</p> <p><b>R304.5.1, R304.2.2</b></p> | | | | Obstruction Type | | |

| Codes/Mitigation Info/Possible Solution | | | Field Measurements/Component Compliance | | | |
|---|---|--|---|---|---|--|
| | <b>Remove &amp; Replace Entire Ramp.</b> | | <b>N/A</b> | Ramp Length (in) | <b>48.0</b> | |

Total Cost: \$ 1600.00
