# Access Compliance Report

## Public Rights-of-Way

### (Curb Ramps)

Intersection ID: 31922	Main Street: RIM_ROCK_CT	Cross Street: STOWE_DERBY_DR	Location: NW
ADA ID: 4533730061E5	Ramp Type: PerpDiag	Initial Pass/Fail: Fail	Overall Compliance: No
Severity Score: 46.25			
Codes/Mitigation Info/Possible Solution		Field Measurements/Component Compliance

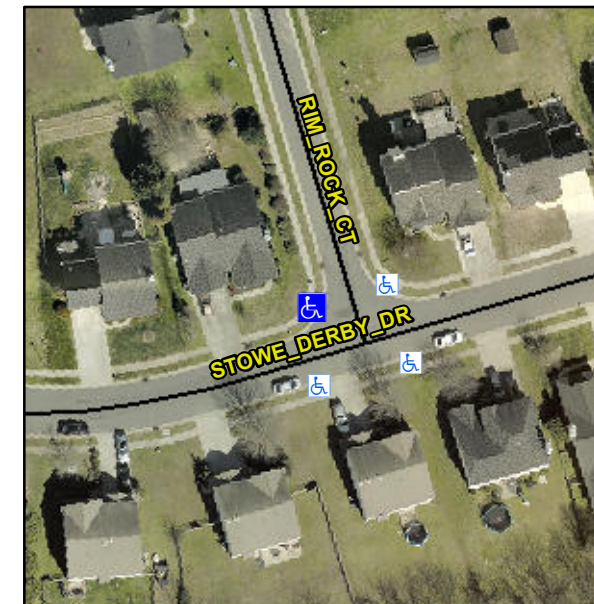
Compliance	Description	Data	Compliance	Description	Data
N/A	Ramp Length (in)	47.5	No	Ramp Slope (%)	9.3
No	Ramp Width (in)	47.0	No	Ramp XSlope (%)	7.1
N/A	Flare Type LT	N/A	N/A	Flare Type RT	N/A
N/A	Flare Slope LT (%)	N/A	N/A	Flare Slope RT (%)	N/A
N/A	Flare Traversable LT?	N/A	N/A	Flare Traversable RT?	N/A
N/A	Landing Length (in)	N/A	N/A	DWS Provided?	N/A
N/A	Landing Width (in)	N/A	N/A	DWS Contrast?	N/A
N/A	Landing Slope (%)	N/A	N/A	DWS Length (in)	N/A
N/A	Landing X Slope (%)	N/A	N/A	DWS Full Width?	N/A
N/A	Landing Curb? (Y/N)	N/A	N/A	DWS Offset (in)	N/A
N/A	Shared Landing?	N/A			
N/A	Gutter Ponding?	N/A	N/A	Gutter Slope (%)	N/A
N/A	Gutter Lip Ht (in)	N/A	N/A	Gutter X Slope (%)	N/A
N/A	Painted X Walk1?	No	N/A	Painted X Walk2?	No
	X Walk 1 Direction	To S		X Walk 2 Direction	To E
N/A	X Walk 1 Width (in)	N/A	N/A	X Walk 2 Width (in)	N/A
	X Walk 1 Slope (%)	4.2		X Walk 2 Slope (%)	2.9
	X Walk 1 X Slope (%)	3.3		X Walk 2 X Slope (%)	4.6

N/A	Ramp inside XWalk1?	N/A	N/A	Ramp inside XWalk2?	N/A
	Road Slope (%)	5.4	N/A	Clear Space?	N/A
	Road X Slope (%)	3.3	N/A	Clear Space to XWalk (in)	N/A
N/A	Any Obstructions?	N/A	N/A	Storm Grate/Utility Hazard?	N/A
	Obstruction Type			Storm Grate/Utility Type	
		N/A			N/A
			Yes	Surface Condition? (G/P)	Good

Possible Solutions:

**Remove & Replace Curb Ramp With Two New Directional Ramps or Equivalent.**
