Access Compliance Report

Public Rights-of-Way

(Curb Ramps)

Intersection ID: 50632	Main Street: CORAL_ROSE_RD	Cross Street: RED_WATER_RD	Location: NE
ADA ID: 45365144C2B6	Ramp Type: Perp	Initial Pass/Fail: Fail	Overall Compliance: No
Severity Score: 21.25			
Codes/Mitigation Info/Possible Solution		Field Measurements/Component Compliance

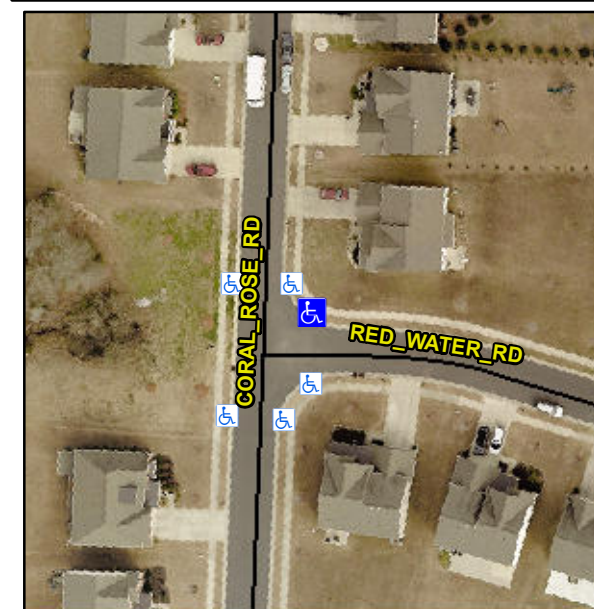
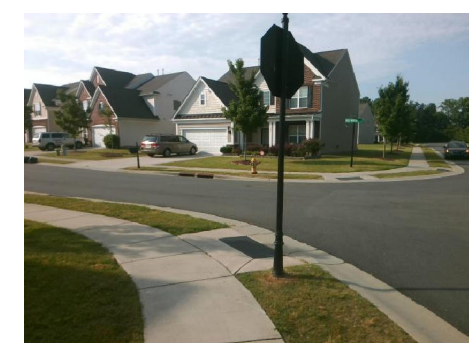
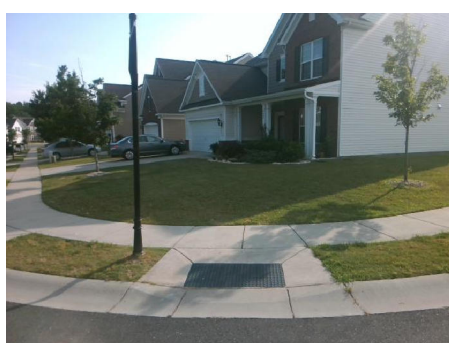
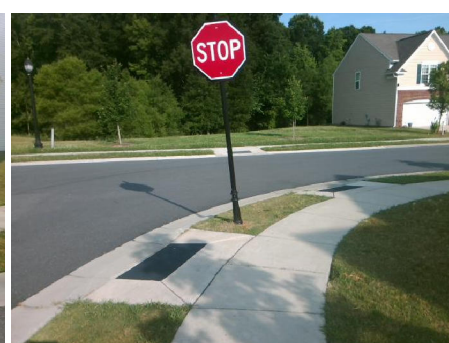
Not Found, R304.5.1, R304.2.2

Compliance	Description	Data	Compliance	Description	Data
N/A	Ramp Length (in)	48.0	No	Ramp Slope (%)	9.5
No	Ramp Width (in)	46.0	Yes	Ramp XSlope (%)	0.8
N/A	Flare Type LT	N/A	N/A	Flare Type RT	N/A
N/A	Flare Slope LT (%)	N/A	N/A	Flare Slope RT (%)	N/A
N/A	Flare Traversable LT?	N/A	N/A	Flare Traversable RT?	N/A
N/A	Landing Length (in)	N/A	N/A	DWS Provided?	N/A
N/A	Landing Width (in)	N/A	N/A	DWS Contrast?	N/A
N/A	Landing Slope (%)	N/A	N/A	DWS Length (in)	N/A
N/A	Landing X Slope (%)	N/A	N/A	DWS Full Width?	N/A
N/A	Landing Curb? (Y/N)	N/A	N/A	DWS Offset (in)	N/A
N/A	Shared Landing?	N/A			
N/A	Gutter Ponding?	N/A	N/A	Gutter Slope (%)	N/A
N/A	Gutter Lip Ht (in)	N/A	N/A	Gutter X Slope (%)	N/A
N/A	Painted X Walk1?	No	N/A	Painted X Walk2?	N/A
	X Walk 1 Direction	To S		X Walk 2 Direction	N/A
N/A	X Walk 1 Width (in)	N/A	N/A	X Walk 2 Width (in)	N/A
	X Walk 1 Slope (%)	0.6		X Walk 2 Slope (%)	N/A
	X Walk 1 X Slope (%)	0.5		X Walk 2 X Slope (%)	N/A

N/A	Ramp inside XWalk1?	N/A	N/A	Ramp inside XWalk2?	N/A
	Road Slope (%)	N/A	N/A	Clear Space?	N/A
	Road X Slope (%)	N/A	N/A	Clear Space to XWalk (in)	N/A
N/A	Any Obstructions?	N/A	N/A	Storm Grate/Utility Hazard?	N/A
	Obstruction Type			Storm Grate/Utility Type	
		N/A			N/A
		Yes		Surface Condition? (G/P)	Good

Remove & Replace Entire Ramp.
