# Access Compliance Report

## Public Rights-of-Way

### (Curb Ramps)

| Intersection ID: 14093 | Main Street: E_4TH_ST | Cross Street: HAWTHORNE_LN | Location: S |

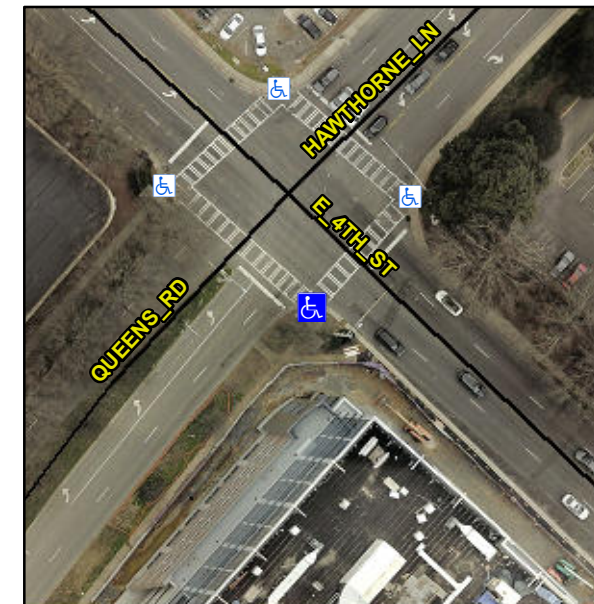
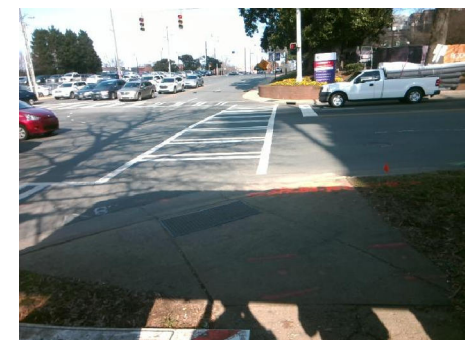
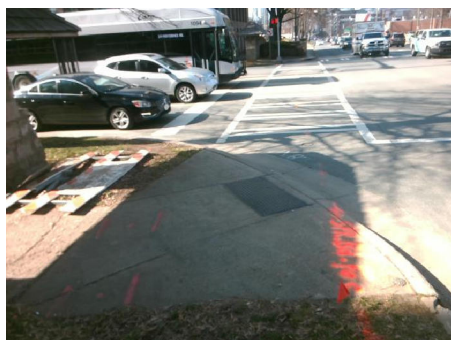
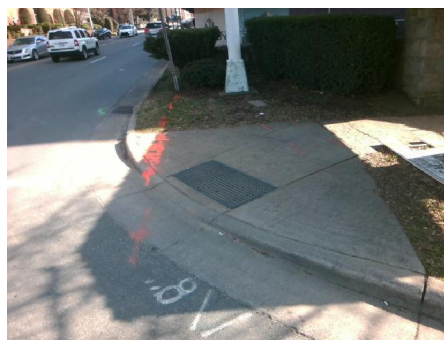
| ADA ID: 453D60DE0F91 | Ramp Type: BlendTrans1 | Initial Pass/Fail: Fail | Overall Compliance: No |

**Not Found, R304.5.1, R304.5.3**

| Compliance | Description | Data | Compliance | Description | Data |
|---|---|---|---|---|---|
| No | Ramp Width (in) | 44.0 | No | BlendTrans XSlope (%) | 6.0 |
| | | | No | Curb Slope (%) | 11.2 |

**Remove & Replace Curb Ramp With Two New Directional Ramps or Equivalent.**
